SERVICE BULLETIN

AUTOMOBILE SERVICE DEPARTMENT

Model	Applicable To	File Under	Bulletin No
ALL	ALL	PDI	87-006
			Issue Date
			OCT 23, '89

Shipping Wax Removal (Supersedes 87-006, dated April 4, 1989)

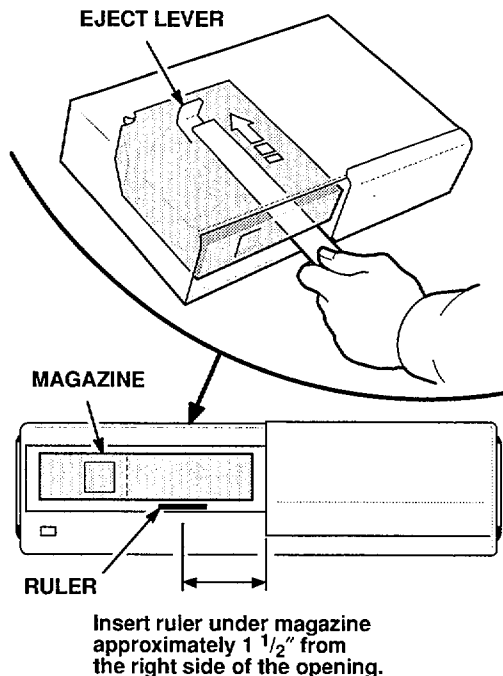
4. After the disc is loaded into the player mechanism, turn the changer so that its front is facing you.
5. Insert a thin stainless steel ruler or a "Slim Jim" under the magazine, about 1 1/2" from the right side of the opening.

6. Push the ruler in until it presses against the eject lever at the back of the unit.
7. Slowly remove the ruler and magazine at the same time.

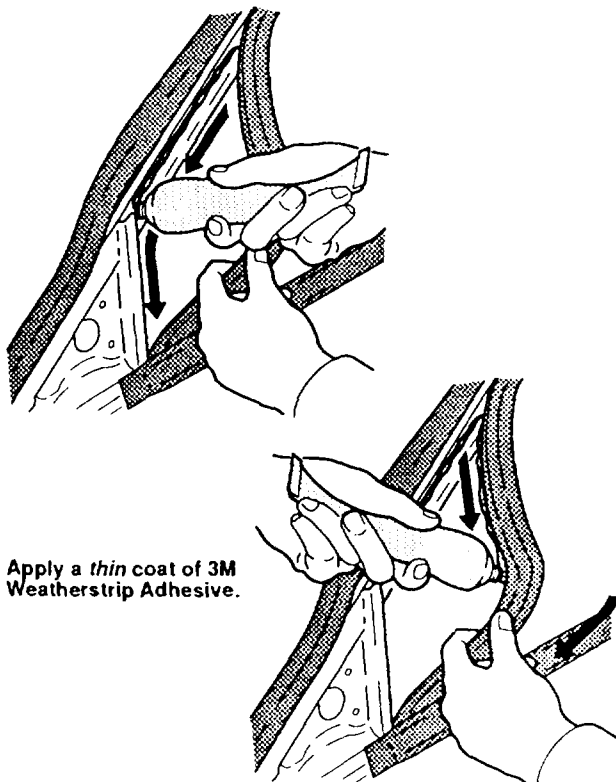
NOTE: This is the **only** adhesive that will work for this repair. Do not use 3M *Super* Weatherstrip Adhesive, yellow Hondaline Weatherstrip Adhesive, or any other adhesive. They will not hold the seal in place, causing a comeback.

Apply a *thin* coat of 3M Weatherstrip Adhesive.

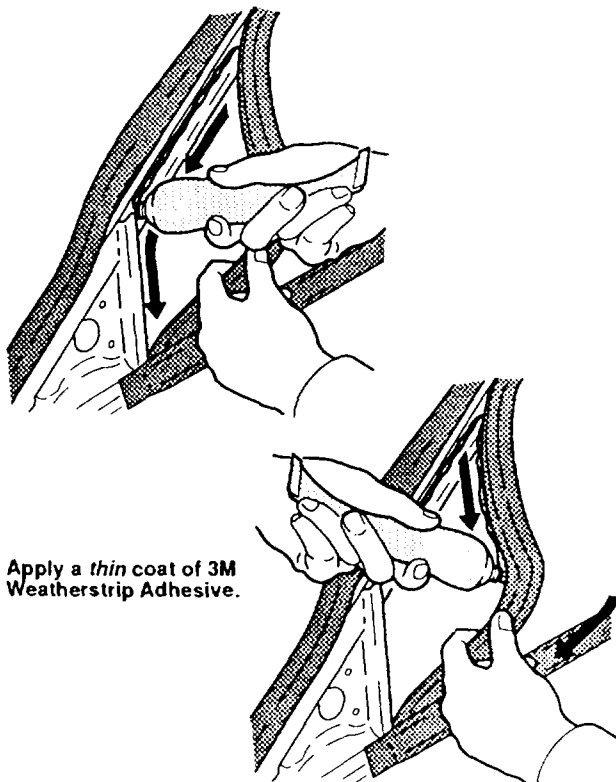
NOTE: This is the **only** adhesive that will work for this repair. Do not use 3M *Super* Weatherstrip Adhesive, yellow Hondaline Weatherstrip Adhesive, or any other adhesive. They will not hold the seal in place, causing a comeback.

Apply a *thin* coat of 3M Weatherstrip Adhesive.

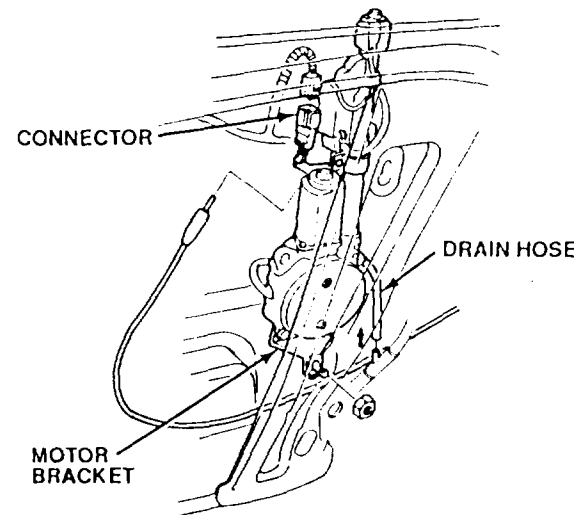
3. Inspect the antenna mast and inside of the mast housing for corrosion. If no corrosion found, clean the mast and housing with Honda Brake Cleaner (P/N PC-HBC265) or equivalent. If either the mast or inside of the housing is corroded, replace the complete antenna assembly.
4. Reinstall the mast as shown in the service manual.
5. Remove the antenna motor mounting nuts and remove the antenna assembly from the trunk.

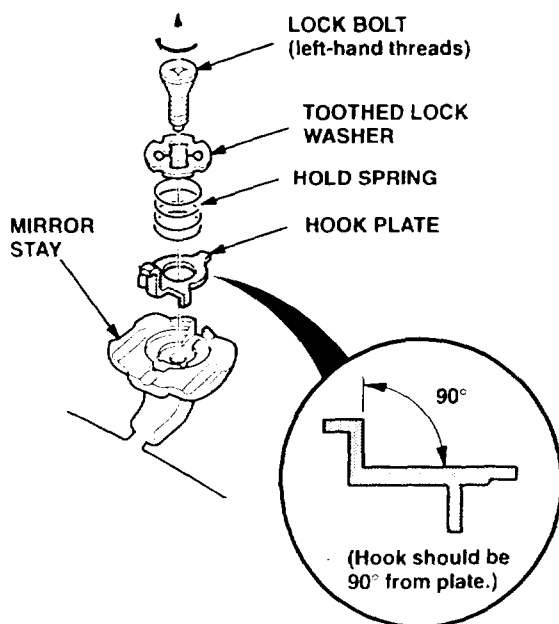
1. Remove the lock bolt from the mirror stay as described in the appropriate service manual.
2. Inspect the hook plate. If the hook plate is distorted, bend it to its original 90° position.

3. Inspect the lock bolt, the toothed washer, and the hold spring. Replace any parts that are missing, broken, or distorted (see PARTS INFORMATION).

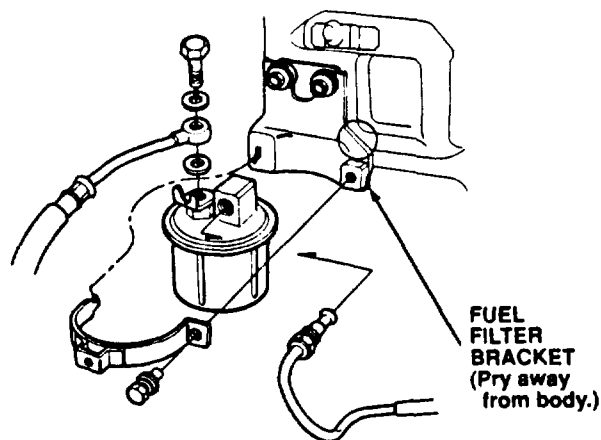
Check for clearance between the filter bracket and the body in the area shown. The bracket is rubber-mounted so it can move, but sometimes the fuel inlet line pushes it against the body. If you find
