SERVICE BULLETIN

AUTOMOBILE SERVICE DEPARTMENT

Model	Applicable To	File Under	Bulletin No
ALL	ALL	PDI	87-006
			Issue Date
			OCT 23, '89

Shipping Wax Removal (Supersedes 87-006, dated April 4, 1989)

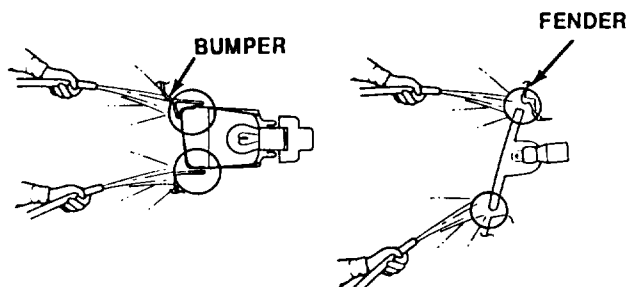
FRONT TURN SIGNALS/PARKING LIGHTS

The main causes of damaged lenses and other external plastic components are using improper procedures and unapproved materials during shipping wax removal. Use only the procedures and approved materials given in this service bulletin.

- Rinse the body thoroughly – pay particular attention to hollow areas around the exterior lights and bumpers. Shipping wax can get trapped in the crevices between light housings and lenses, and gaps between the bumpers and body. Spray these areas liberally to make sure all the residue is removed.

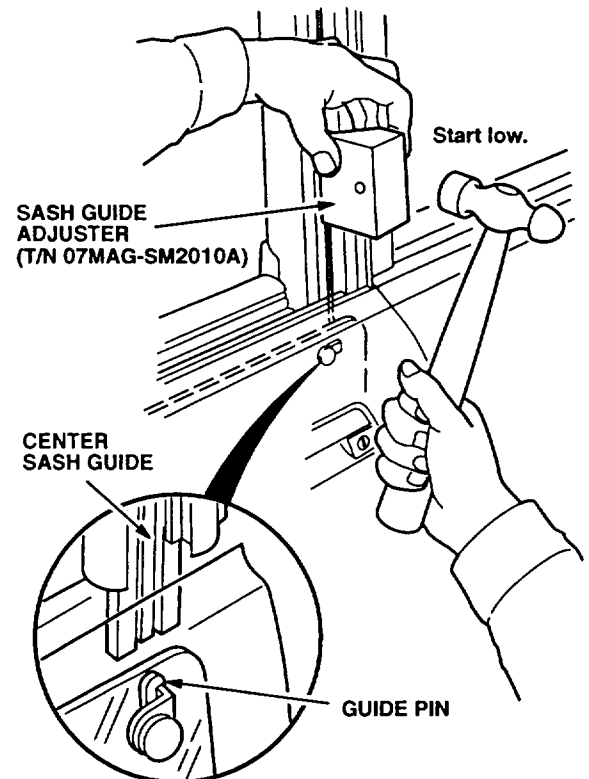
- Roll the window halfway down. Check the amount of play in the center sash guide by moving the glass in and out.
 - If the window can be moved in and out, continue to step 2.
 - If the window cannot be moved in and out, go to step 7.

- Roll the window all the way down. Insert the Sash Guide Adjuster (T/N 07MAG-SM2010A) in the lower half of the center sash guide slot; then hit the tool with a ball peen hammer.

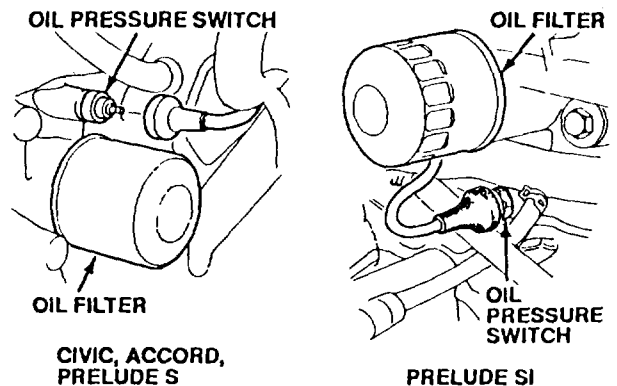
Inspect the oil pressure switch to determine if it has a green plastic end or black plastic end. If it is green plastic, replace it with the switch listed under PARTS INFORMATION.

1. Raise the car on a hoist.
2. Locate the oil pressure switch by the oil filter. Inspect the plastic end to see what color it is. On the Prelude Si, the wire is bolted to the switch so you must fold back the rubber boot to see the end. On all other models, remove the wire and boot by pulling them straight off.

3. a) If the switch has a black plastic end, reconnect the wire and boot and go to step 4.
b) If the switch has a green plastic end, replace it with a new unit. Coat the threads with a 3 mm wide bead of Liquid Gasket (P/N 08718-0001) before installation. Torque the switch to 1.8 kg-m (13 lb-ft).
4. Lower the hoist. Check the engine oil level and add as needed.
5. Center punch a completion mark over the last digit in the VIN on the engine bulkhead.

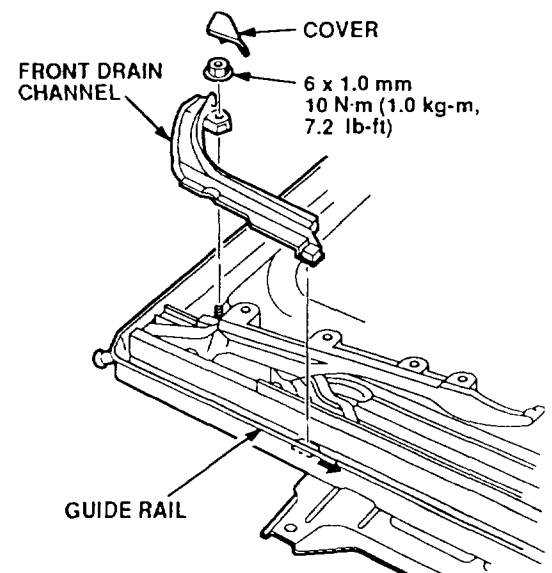
Front Drain Channel Interference

1. Open the sunroof, and apply tracing powder or baby powder to the tops of both front drain channels.
2. Close and open the sunroof several times. Check the powder to see if the sunroof panel has come in contact with it. If not, go to step 4.
3. If the sunroof panel has disturbed the powder on either side, replace that drain channel with the appropriate part listed under PARTS INFORMATION.
 - Pry off the plastic cover, then remove the nut holding the front drain channel. Lift the channel off the stud, and slide it forward. Flex the center part of the channel, and rotate the front up into the sunroof opening. Slide the channel forward until the rear clears the lip of the guide rail. Remove the drain channel.

- Install the new channel in reverse order.
- Replace the other drain channel if necessary.

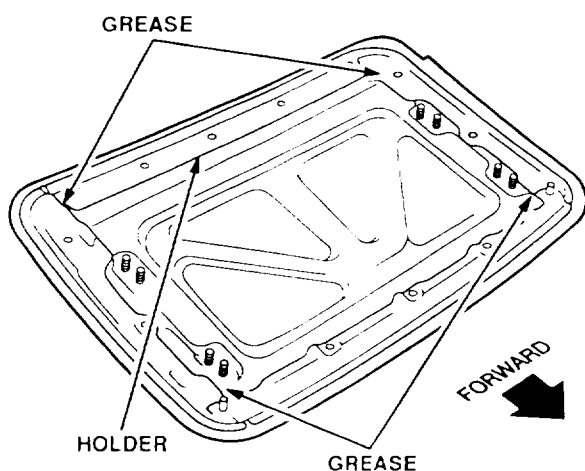
Seal Holder Interference

4. Remove the sunroof liner and panel as shown in the appropriate service manual.
5. Remove all four seal holder plates from the sunroof panel. Examine the plates for shiny spots that indicate they have been rubbing against each other or the sunroof panel.
6. Apply multipurpose grease to the areas of contact between the panel and plates.

7. Reinstall the seal holder plates.

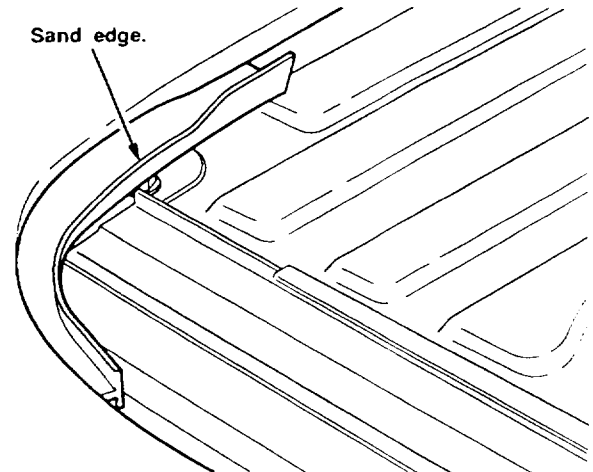
PROBABLE CAUSE

2. Remove the sunroof panel liner.
3. Remove the sunroof panel.
4. If the height of the sunroof panel measured more than 1.4 mm higher than the roof panel in step 1, sand the edge of the rear drain channel on the side that squeaks to remove any high spots.

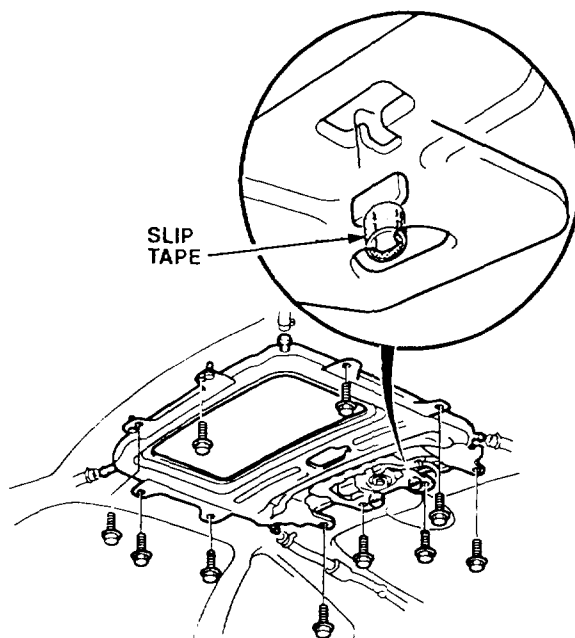
PROBABLE CAUSE

2. Wrap both of the sunroof frame rear hooks with slip tape (see PARTS INFORMATION) as shown.

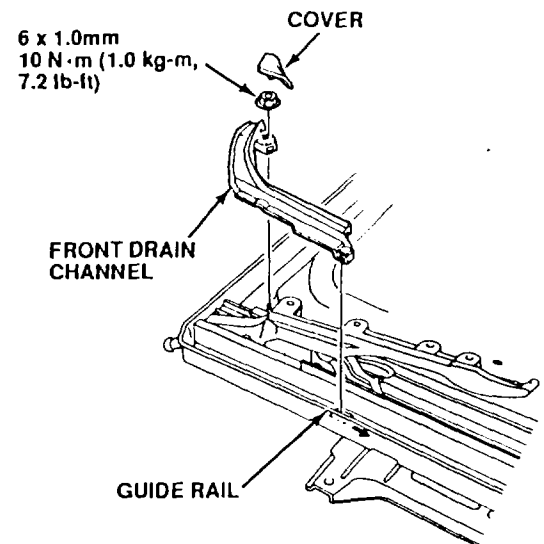
1. Open the sunroof and apply tracing powder or baby powder to the tops of both front drain channels.
2. Close and open the sunroof several times. Check the powder to see if the sunroof panel has come in contact with it. If not, go to step 4.
3. If the sunroof panel has disturbed the powder on either side, replace that drain channel with the appropriate part listed under PARTS INFORMATION.

- Pry off the plastic cover, then remove the nut holding the front drain channel. Lift the channel off the stud and slide it forward. Flex the center part of the channel and rotate the front up into the sunroof opening. Slide the channel forward until the rear clears the lip of the guide rail. Remove the drain channel.

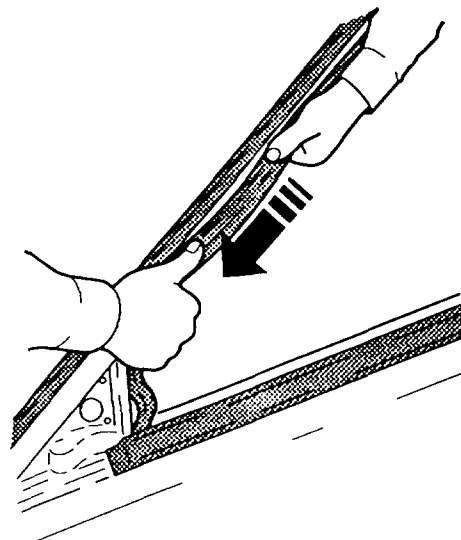
The run channel seal comes out of the channel by the door mirror. This causes wind noise and poor appearance.

2. Slide the run channel seal down toward the mirror base.

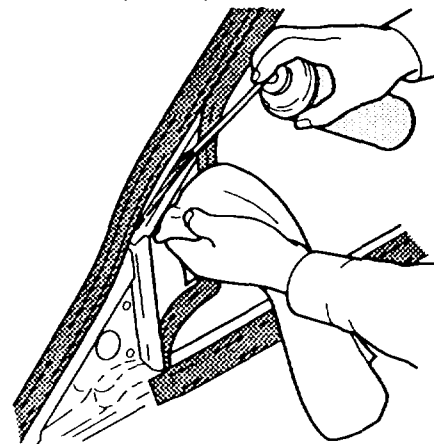
NOTE: Inspect the seal and run channel carefully to make sure all residue from lubricants is removed. The adhesive will not bond properly if any residue is left.

3. Remove the run channel seal from the area shown. Protect the body and door panel with a shop towel. *Thoroughly clean the run channel and the seal with brake cleaner.*

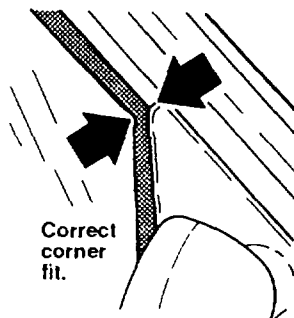
Correct corner fit.

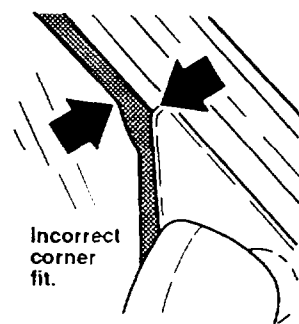
Incorrect corner fit.

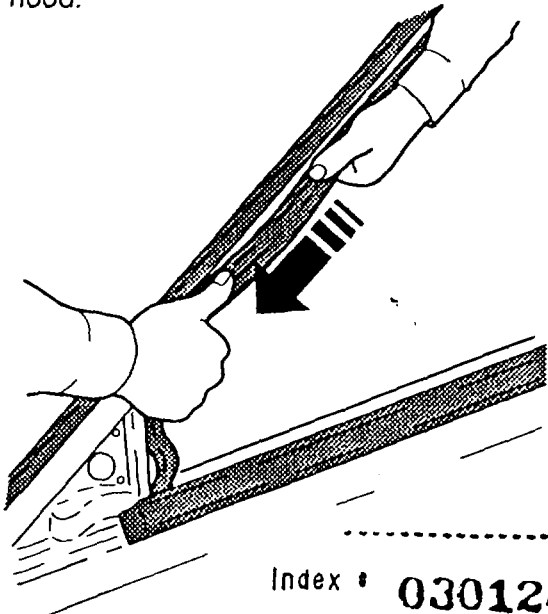
Wind noise from the front door mirror area. The window run channel seal is loose or deformed around the front mirror.

1. Remove the outer door mirror according to the procedure in the Service Manual.
 - Prelude – remove the door panel to gain access to the door mirror.
 - Accord – remove the outside mirror.
2. Slide the run channel seal down, toward the hood.

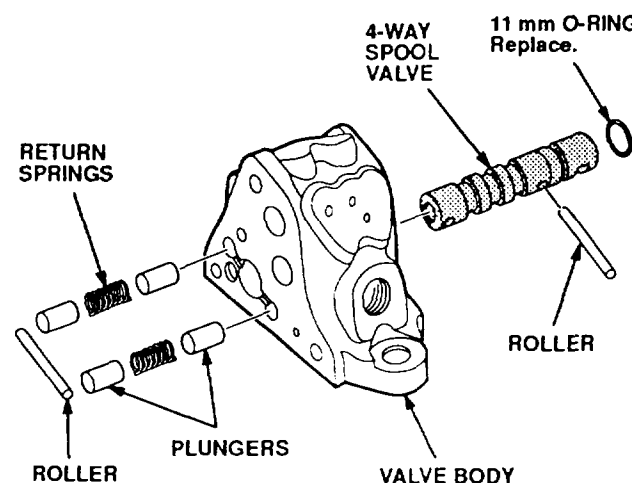
P/N 53647-SM4-010, H/C 3595105

Power steering 4-way spool valve is defective.

Remove and replace the power steering 4-way spool valve (see PARTS INFORMATION). Refer to page 17-106 of the service manual for the replacement procedure.

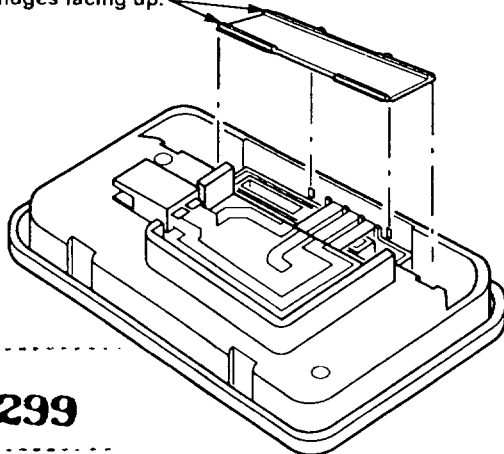
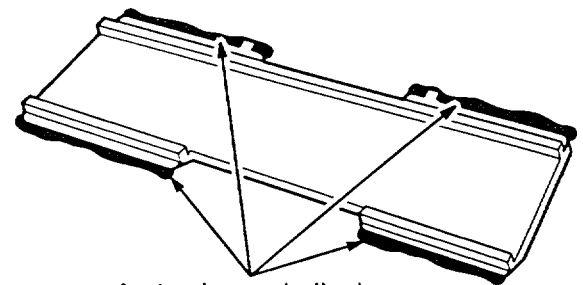
The switch cover comes loose, allowing the electrical contacts to separate.

1. Remove the ceiling light assembly as shown in Section 23 of the appropriate service manual.
2. Make sure the switch slider is seated down fully in its slot. Push on the three brass contact fingers to make sure they are seated against the slider.
3. Trial fit the plastic switch cover into the light assembly. Make sure the ridged side is facing up and the large notch faces toward the inside of the light as shown below. Make note of the cover's position; you will not be able to re-position it after you install it with the quick-drying adhesive applied. Remove the cover.

4. Apply primer from the repair kit (see REQUIRED MATERIALS) to the switch cover in the areas shown.

Apply primer and adhesive.

5. Apply one or two drops of the adhesive in each of the same areas. Immediately install the switch cover on the light assembly.
6. Install the ceiling light assembly.

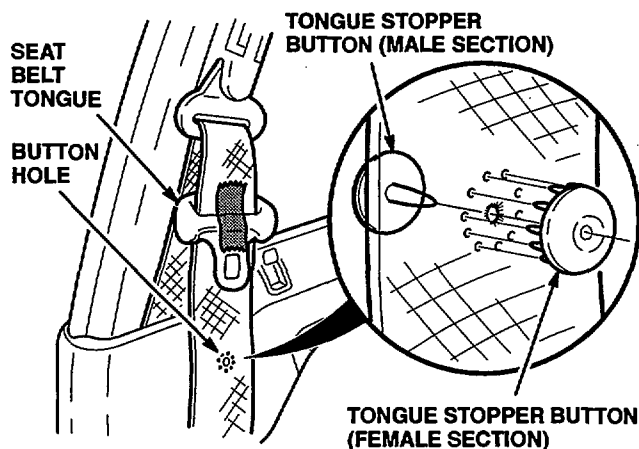
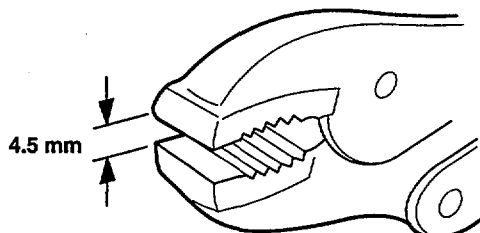
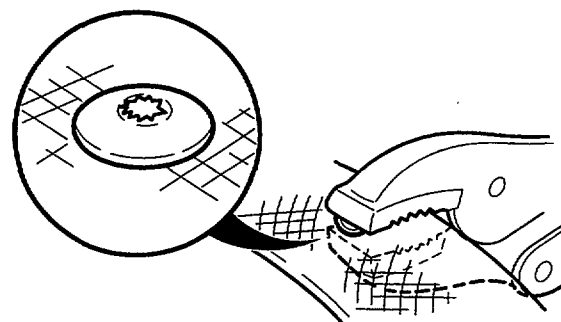
The seat belt tongue stopper button is broken, allowing the tongue to slide down to the floor.

Install a new seat belt tongue stopper button listed under PARTS INFORMATION.

1. Slide the seat belt tongue up the seat belt past the tongue stopper button hole. Temporarily secure the seat belt tongue to the belt fabric with masking tape.
2. Insert the male section of the button through the hole in the belt fabric. Align and install the female section of the stopper to the male section.

3. Preset the closed gap on a pair of vise-grip pliers to 4.5 mm.

4. Place the flat portion of the jaws over the tongue stopper, and squeeze until the vise-grip jaws lock and deform the stopper shaft.

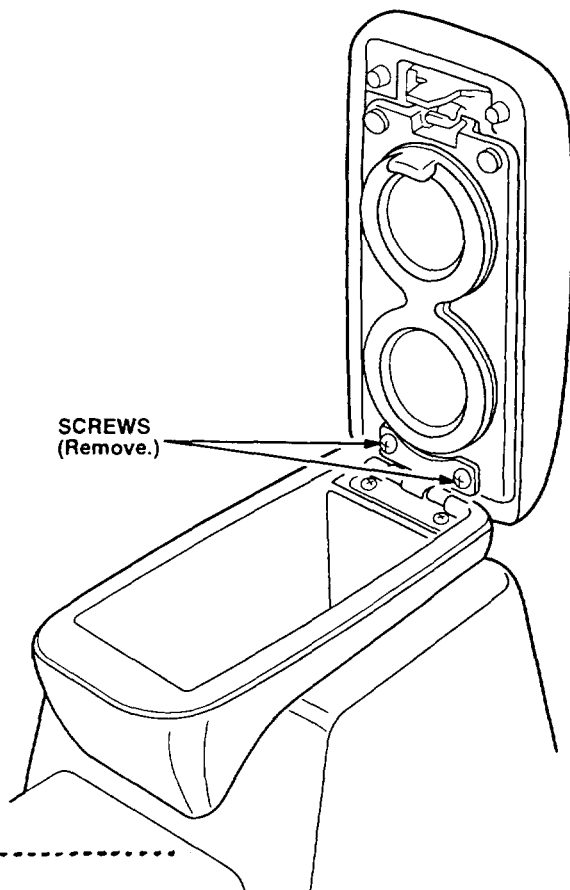
The cupholder in the armrest is broken.

Replace the cupholder assembly with the part listed under PARTS INFORMATION.

1. Lift the top of the armrest.
2. While holding the acorn nuts on the back side of the cupholder, remove the two Phillips-head screws.

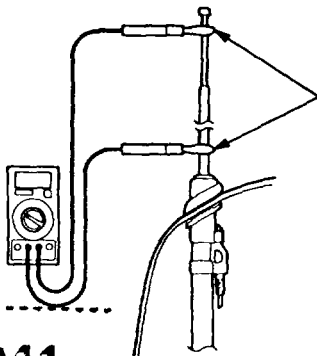
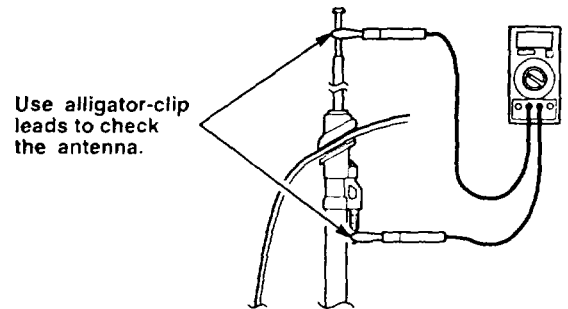
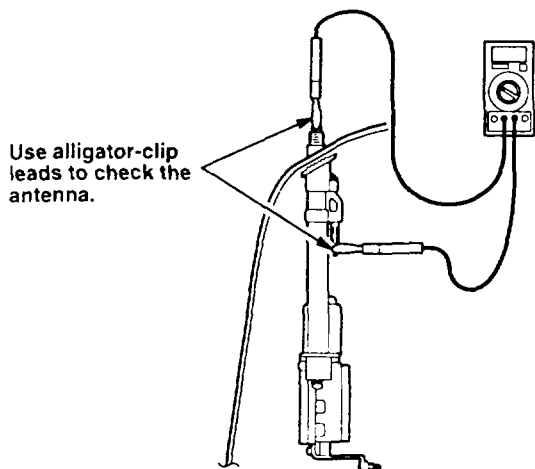
1. Corrosion of the antenna mast or tube or a damaged coaxial cable can cause poor reception.
2. Poor grounding of the antenna collar or tube or a damaged coaxial cable can cause electrical noise or static over the radio speakers.

1. Turn the ignition switch ON; then, turn the radio on to extend the antenna mast.
2. Measure the resistance between the top section and the bottom section of the antenna mast.

- If the resistance is more than 10 ohms, go to CORRECTIVE ACTION, Antenna Mast Replacement.
- If the resistance is less than 10 ohms, continue with step 3.

- If the resistance is less than 10 ohms, go to **CORRECTIVE ACTION, Antenna Mast Replacement.**
- If the resistance is more than 10 ohms, go to **CORRECTIVE ACTION, Antenna Tube Replacement.**

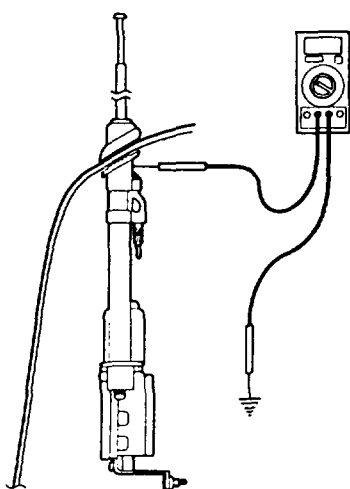
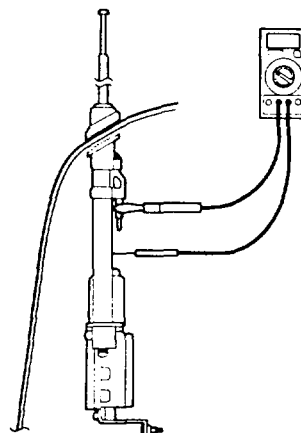
1. Disconnect the coaxial cable from the antenna jack.
2. Measure the resistance between the antenna collar and body ground.

- If the resistance is more than 1 ohm, go to **CORRECTIVE ACTION, Antenna Collar Replacement.**
- If the resistance is less than 1 ohm, continue with step 3.

- If the resistance is more than 1 ohm, go to **CORRECTIVE ACTION, Antenna Tube Replacement.**
- If the resistance is less than 1 ohm, continue with Coaxial Cable Test.

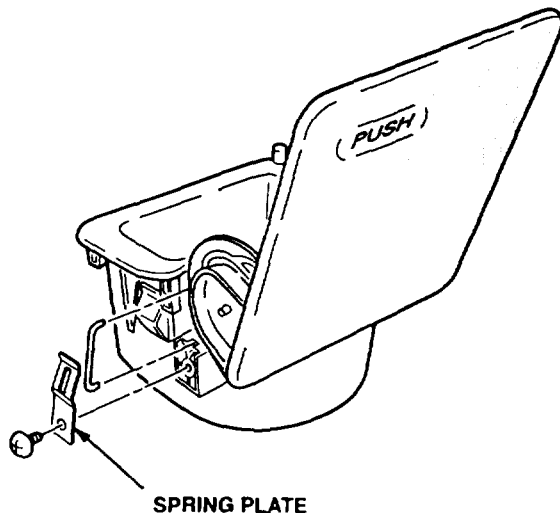
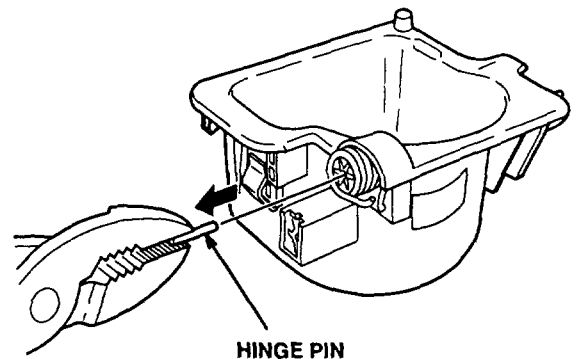
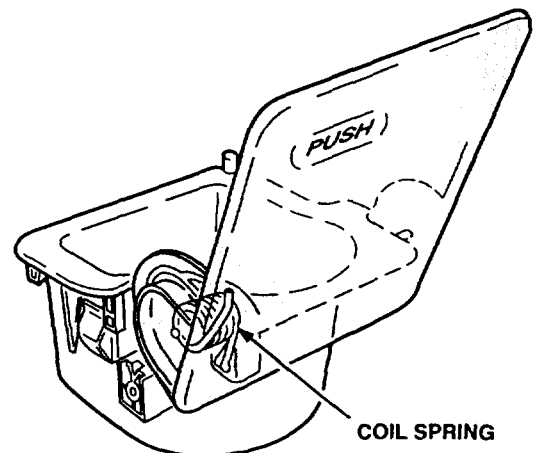
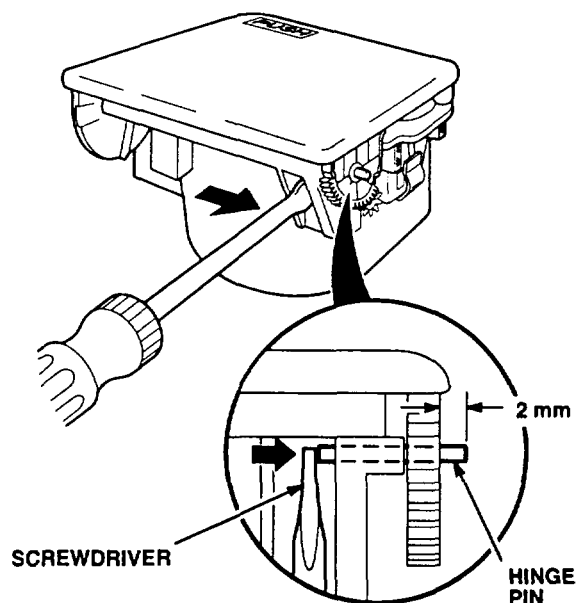
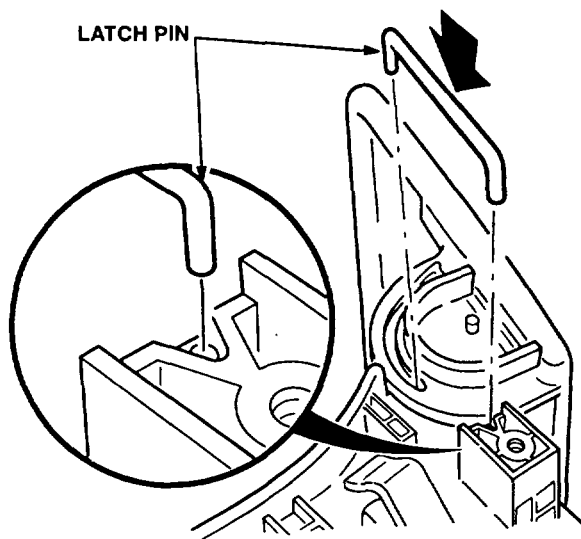
PROBABLE CAUSE

Reposition the hinge pin, and replace the latch pin with the new part listed under PARTS INFORMATION.

1. Remove the cup holder from the console by pulling up on the inside of the cup holder with your fingers.
2. Remove the spring plate.

3. Remove the cup holder lid by inserting a small screwdriver between the cup holder body and the lid on the spring plate side; then, gently pry the lid off the hinge pin.

4. Use a pair of pliers to remove the hinge pin on the spring plate side of the cup holder. Replace the hinge pin if the original is lost (see PARTS INFORMATION).

5. Reinstall the lid on the cup holder body. Make sure the arms on the coil spring are positioned properly.

6. Reinstall the hinge pin removed in step 4. Position the pin so it sticks out approximately 2 mm above the lid.

7. Reposition the other hinge pin by using a small screwdriver to push the pin outward. Position the pin so it sticks out approximately 2 mm above the lid.

8. With the lid open, install the new latch pin in the notch in the body and the slot in the lid.

9. Install the spring plate over the latch pin and tighten the screw.
10. Open and close the cup holder several times to test its operation.
11. Reinstall the cup holder in the console.

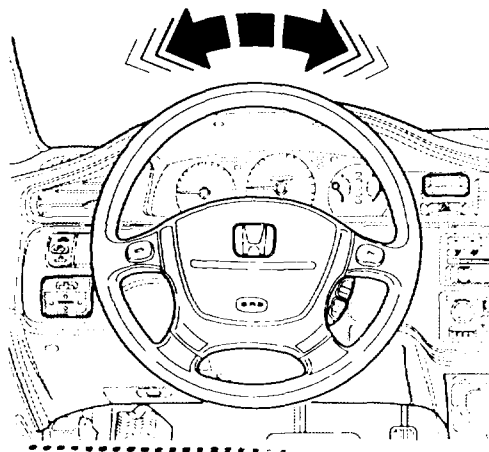
1. Drive the car on a smooth surface between 58 and 62 mph. Turn the steering wheel slightly, and allow the steering to self-center. Repeat this several times and observe the steering wheel motion.
 - If the steering wheel does not oscillate, or the movement is different than shown below, the car does not have an imbalance problem. Do not continue with this procedure.
 - If the steering wheel oscillates as shown, continue with this procedure.

Dynamically balance the wheel and tire assembly off the car. Then, if necessary, use the Hofmann Finish Wheel Balancer to balance the wheel/tire/hub/disc assembly on the car.

2. Dynamically balance all four wheel/tire assemblies off the car. Make sure the balancer is capable of balancing to an accuracy of within 5 grams. Use only Honda wheel weights (see PARTS INFORMATION).

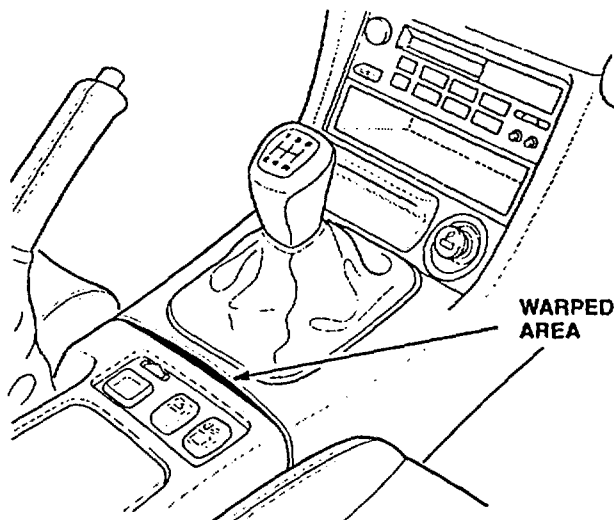
The front console is warped at the seam with the center console.

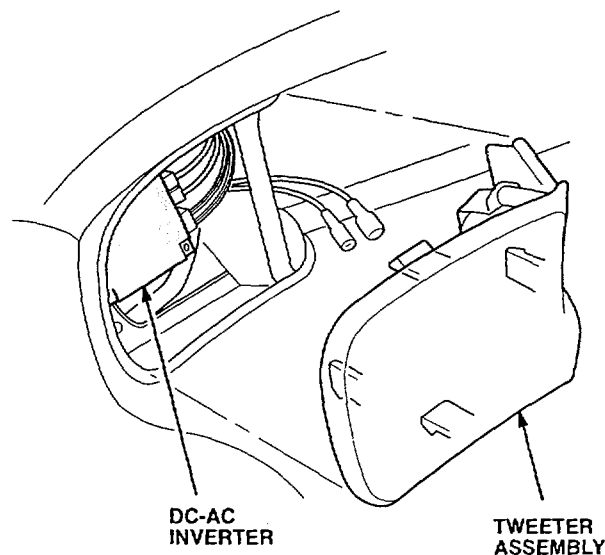
The housing of the DC-AC inverter is loose.

Remove the left tweeter assembly by carefully prying on its edges. Try to reproduce the noise either by tapping on the top of the dashboard with your fist, or by driving the vehicle on a rough road. If you can reproduce the noise, apply pressure to the DC-AC inverter. If the noise disappears, continue with CORRECTIVE ACTION.

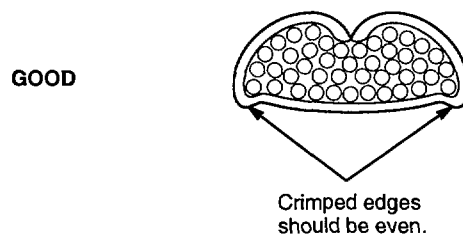
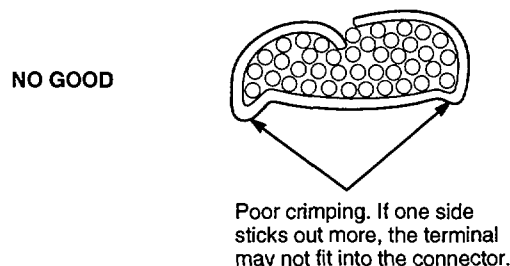
- Inspect the quality of the wire crimp. If it has any of the following problems, cut it off and start over.

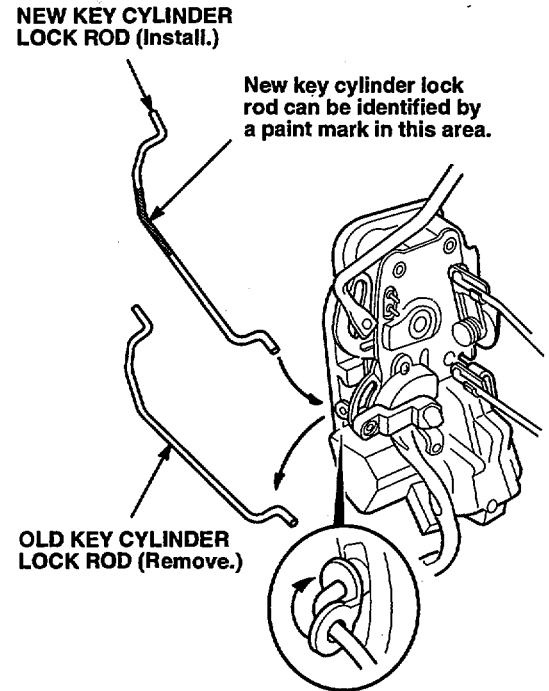
Due to production differences, the dimensional layout of the power door lock system has some variance that may cause the system not to function as designed. To ensure proper operation and the intended level of security, the passenger's door key cylinder lock rod needs to be replaced.

13. Remove the key cylinder lock rod. Install the new rod listed under PARTS INFORMATION.

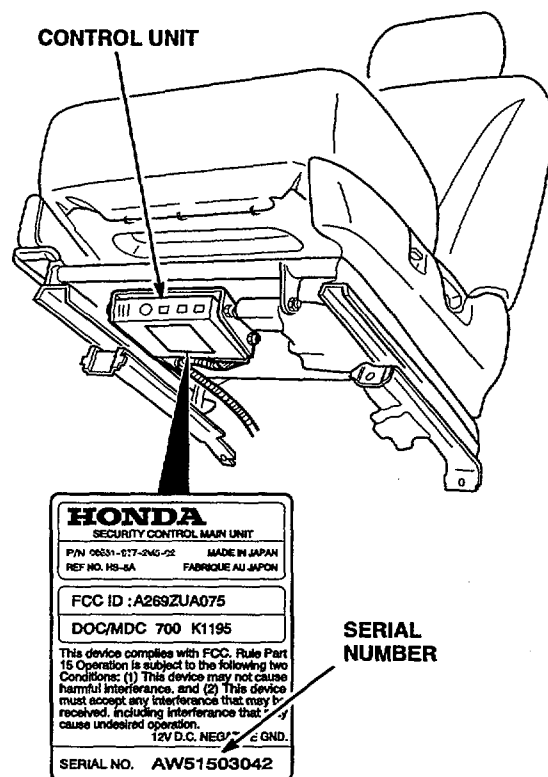
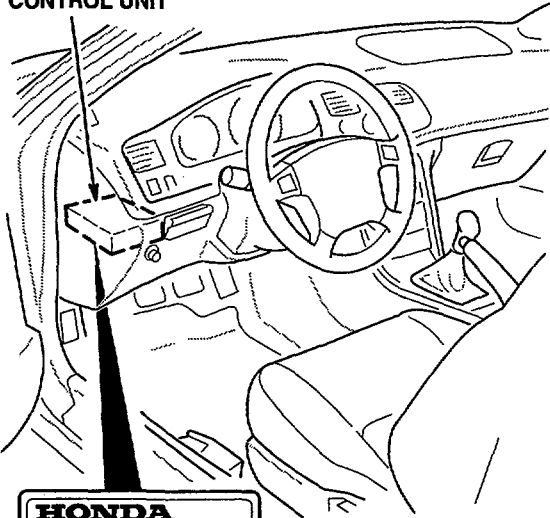
ACCORD V6
CONTROL UNIT

- On the Accord V6, the control unit is mounted behind the steering column lower cover. Look behind the cover to check the serial number on the bottom of the control unit.

- If the control unit serial number is from AW51500018 to AW51507006, replace it (see PARTS INFORMATION). After replacing the control unit, reprogram *all* the transmitters for the vehicle. Transmitters that have not been reprogrammed will no longer work (see TRANSMITTER PROGRAMMING).
- If the control unit is not within the affected serial number range, make sure the security system is *not* in Valet mode, then replace the battery in the transmitter, and check the system operation.
- If the transmitter's range is still too short, check the system with the customer's other transmitter or a known-good transmitter. To program a known-good transmitter for this test, refer to TRANSMITTER PROGRAMMING.
- Replace the original transmitter if the system works with the customer's other transmitter or the known-good transmitter. To program a new transmitter, refer to TRANSMITTER PROGRAMMING.

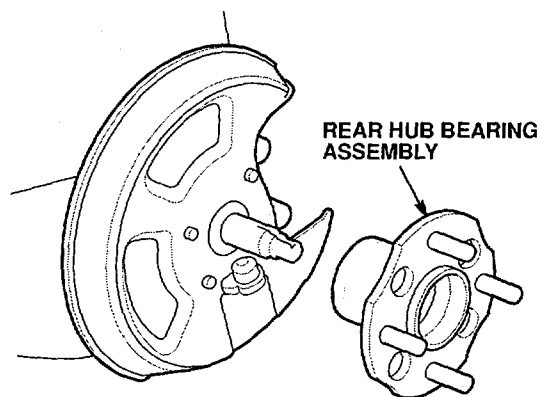
The rear bearing hub caps were not manufactured correctly, allowing water to leak into the hub bearing assemblies, and contaminating the bearings.

1. Determine which rear hub bearing assembly has failed, and replace it with the correct one listed under PARTS INFORMATION. Refer to section 18 of the appropriate service manual for instructions.

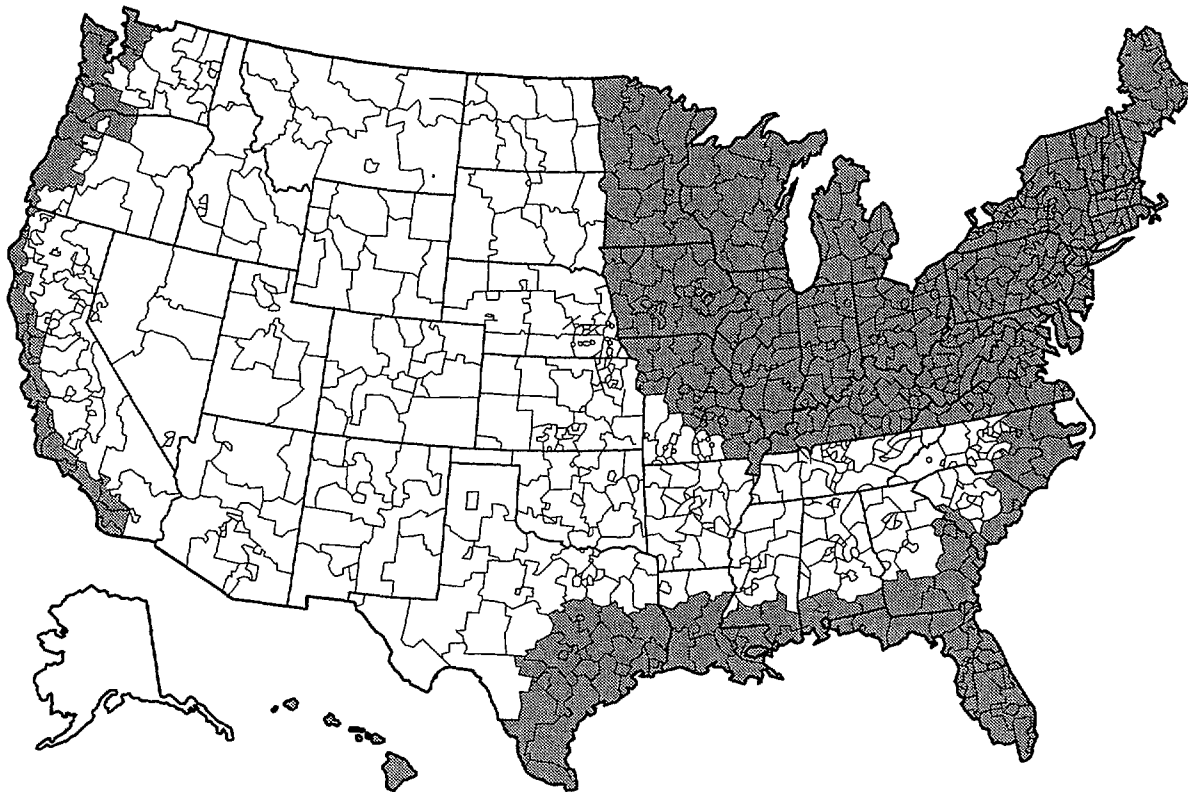
Gray Areas Are Included in This Product Update Campaign

Listed below are the states included in this product update campaign. States that are only partially involved are divided by zip code. The first three digits of the zip code are listed. Customers living in these states and zip codes will be sent letters asking them to get their cars repaired at a Honda dealer.

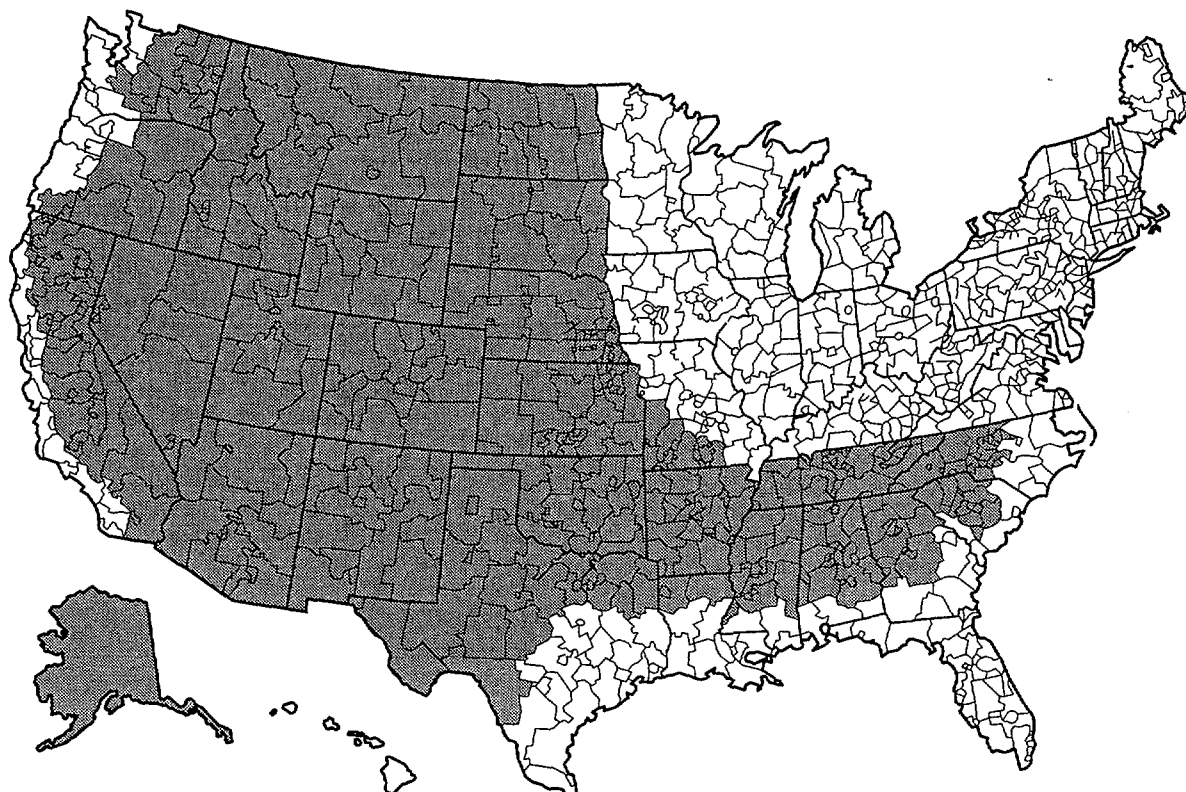
Gray Areas Are Included in the Warranty Extension

Owners living in the shaded area of the map will be notified that the warranty on the A/C condenser has been extended. They will be advised to contact the dealer for repair only if the A/C system fails. An example of the customer letter is at the end of this service bulletin.

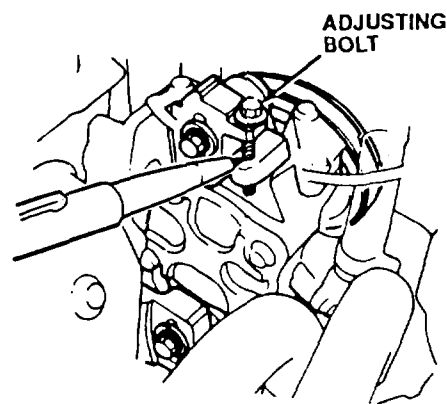
When installing A/C on a '92 Civic, make sure you don't overtighten the compressor and power steering pump belts. These ribbed belts don't "self-adjust" like a V-belt, and once overtightened, they stay too tight, putting extra load on the related components.

Before you remove the P/S pump belt, mark the threads on the adjusting bolt with a dark color felt-tip pen. Then, when you readjust the belt, tighten the adjusting bolt down to its original position.

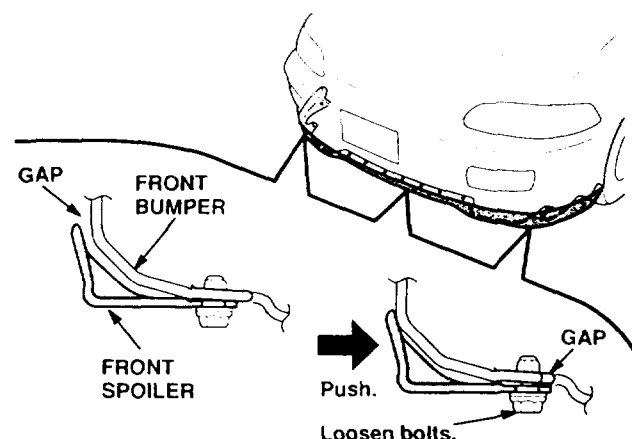
A gap between the front spoiler and the bumper on a '92-'95 Civic can be eliminated by readjusting the spoiler. Loosen the spoiler mounting bolts. (If you find the spoiler mounting holes are elongated or torn at this point, replace the spoiler before proceeding.) Push the clip nuts and the spoiler toward the rear of the car (so there's a gap between the edge of the bumper and the back of the clip). Then, retighten the mounting bolts (start in the middle and work outwards). If the clips slide forward when you tighten the bolts, remove the clips and squeeze them together to increase their tension.

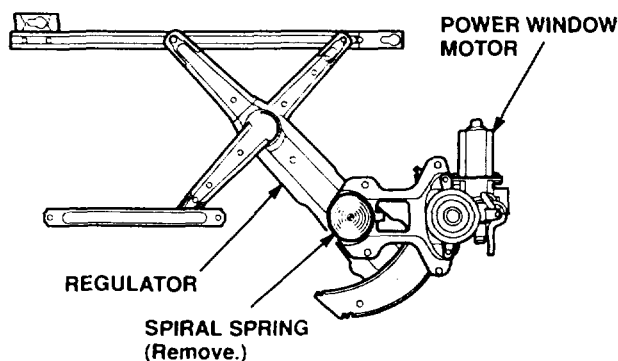
A creaking noise when you raise or lower one of the power windows on a USA- or Canada-produced '94 Civic can be eliminated. Just remove the spiral spring from the window regulator. That's right – this spring isn't really necessary; the factory has already discontinued it.

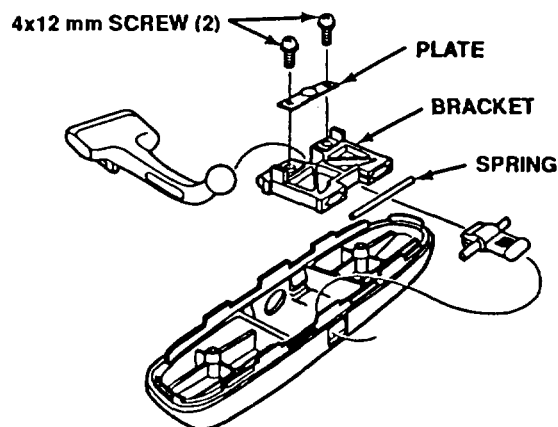
A Mirror Bracket Set is now available to repair an internally damaged rearview mirror. The kit consists of a plate, bracket, spring, and two 4 x 12 mm screws. The P/N's and applications are:

'82-87 Accord 4-door
& '83-87 Prelude: P/N 06764-SG0-000
'82-87 Accord 3-door: P/N 06764-SA5-003

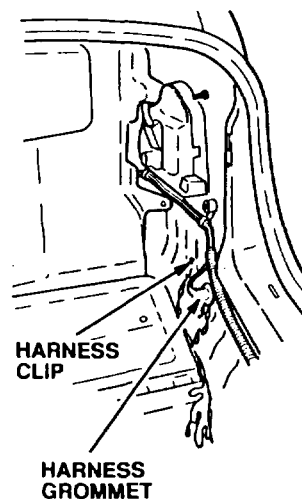
Water in the trunk area of a '92 Prelude may be coming from the right side marker harness grommet or a nearby harness clip.

To confirm the cause, remove the trunk rear trim panel and run some water around the edges of the taillight and bumper. If the water is coming from the grommet or clip, seal them with 3M Super Weather-strip Adhesive (3M #08011).

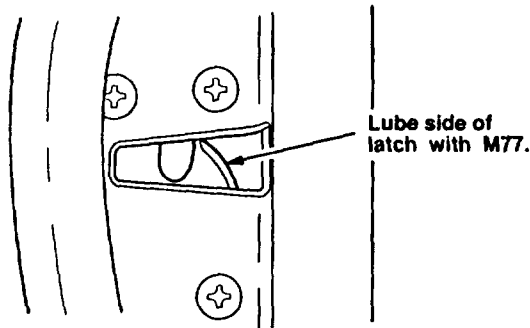
Here are two possible causes (and the cures) for "B" pillar creak on a '90-92 Accord Sedan.

One possible source is a front door latch. Test drive the car to determine what conditions produce the noise (accel, decel, turning, etc.). Now try to duplicate the noise while holding the door open slightly. If the noise goes away with the door open, lube the latch with M77. Open the door, then push the latch to the closed position with a screwdriver. Now lube the side of the latch that touches the housing when the door is closed.

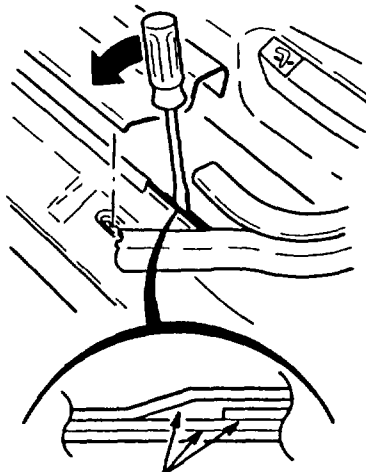
If the latch isn't the source of the noise, it may be the sheet metal joint at the base of the "B" pillar. Remove the front door sill molding and pull up the rear end of the door trim. Look under where the sill molding and door trim meet in front of the "B" pillar – you'll see a gap in the weld flange where four panels meet. Working through that gap with a #2 flat tip screwdriver, pry those four panels apart just slightly. Test drive the car to make sure the noise is gone, then reinstall the door trim and sill molding.

Pry at these points as necessary.

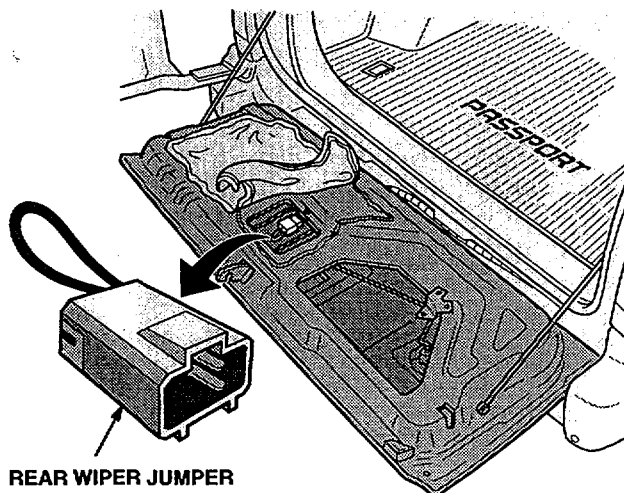
REAR WIPER JUMPER

If the tailgate release still won't work on an LX model (which has no rear wiper), the rear wiper jumper in the hatch harness may be missing. If it's missing, order a wiper motor jumper, P/N 8-97104-874-0, H/C 4463162.

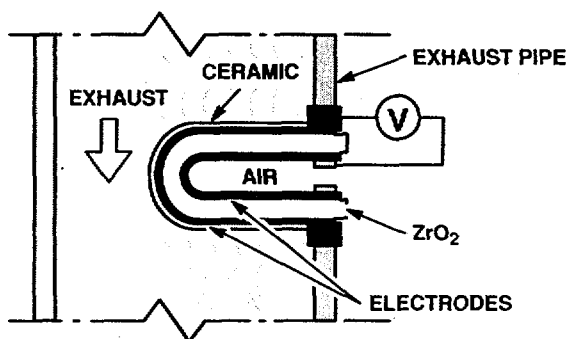
The heart of a typical O₂S is a thimble-shaped element made of a special material called zirconium dioxide (ZrO₂). The inner and outer surfaces of this element each have an electrode made of a layer of thin porous platinum. The O₂S is designed so that the inner surface of this element is exposed to ambient air (the atmosphere), while the outer surface, which also has a porous ceramic coating, is exposed to the exhaust gases.

When the exhaust side of the element is exposed to silicone, the pores of the protective ceramic coating become clogged. Once this occurs, the exhaust side receives less oxygen. As a result, the O₂S generates more voltage than it normally would for a given air/fuel mixture. This may cause the ECM to lean the

If the ambient air side of the element is contaminated with silicone, the porous electrode becomes clogged, reducing the oxygen on that side. Then the O₂S will generate less voltage, so the ECM tries to compensate by richening the mixture. This too may deteriorate driveability or trigger the MIL.

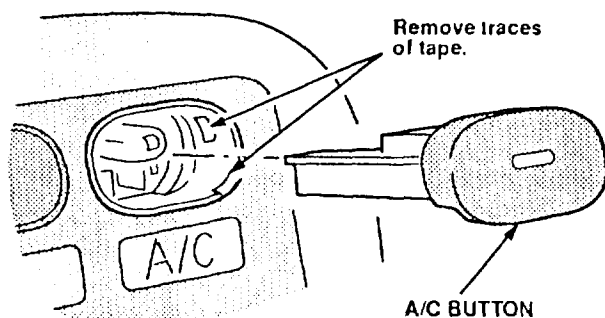
Before replacing a '92 Civic 3-door heater control panel for a sticking A/C button, check the button receptacle for stray pieces of double-sided tape. (The factory applies the tape to the A/C switch hole cap, but pieces of it may end up in the control panel when the cap is removed.) Pull the A/C button out of the control panel so you can check the receptacle thoroughly. Remove any traces of tape with tweezers, then reinstall the button and retest the switch. The factory changed the taping procedure after VIN 2HGEH . . . NH504496, so you shouldn't see this problem on later cars.

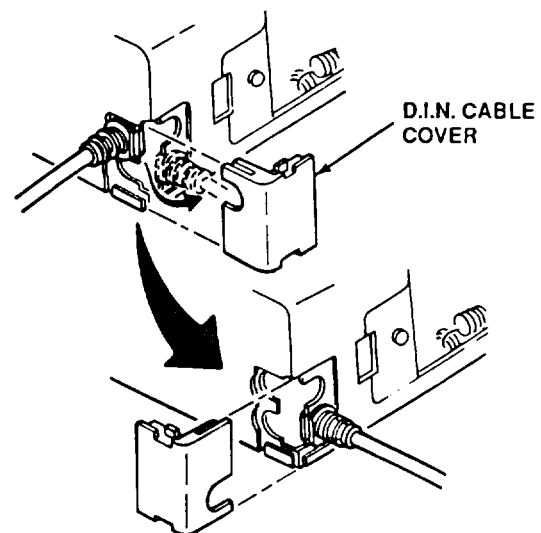
The DIN cable on the trunk-mounted CD changer may interfere with the changer mounting bracket in some applications. If so, reposition the cable as described below:

1. Remove the side cover from the DIN cable side of the changer.
2. Remove the DIN cable cover by sliding it away from the cable.
3. Slide the cable grommet out of its original position and move it to the alternate position.

4. Reinstall the DIN cable cover and the changer side cover.

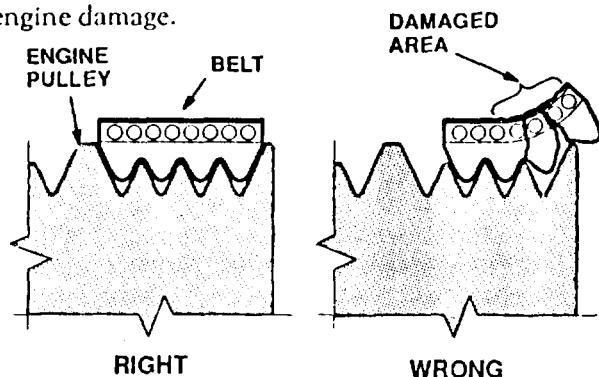
Installing ribbed A/C and P/S belts may seem foolproof, but you'd be surprised how many of them are installed one groove off on the engine pulley. If allowed to run in this condition, the pulley flange can cut the belt in half longitudinally. We've even seen cases where the belt rubbed through the timing cover, destroying the timing belt and causing major engine damage.

So double-check your belt installations, and check the belts on all cars coming in for service.

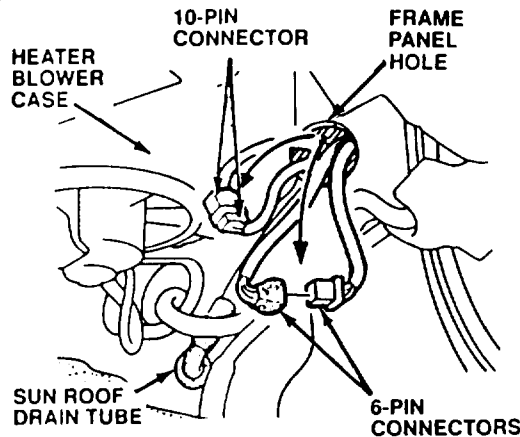
→ **Prelude Security System:** If you're looking for the c-P connector that powers the door locks behind the right kick panel (like on a '92), you won't find it. On a '93 model, the connector is behind the sheet metal below the A-pillar, accessible through a hole. If you had used the '93 instructions, you would have found it. (Those of you that didn't have been calling Tech Line.)

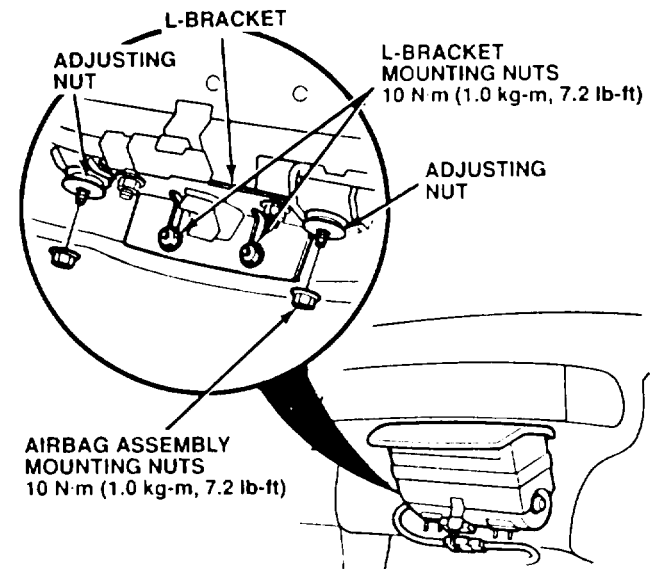
A Prelude passenger airbag that doesn't fit quite flush with the dashboard can usually be adjusted. The adjustment range is limited, however, so you may not get a perfect fit every time.

1. Check how the airbag top cover aligns with the dashboard. Note which side sits high.
2. Remove the glove box as described in the service manual.
3. Loosen the two outer airbag mounting nuts (the ones that secure the adjusting nuts) and the two L-bracket mounting nuts.

4. Back-off the airbag adjusting nut on the side of the airbag that sits too high.
5. Press down on the high side of the airbag, then turn the adjusting nut until it contacts the bottom of the airbag. Retighten the two airbag mounting nuts.
6. Retighten the two L-bracket mounting nuts.
7. Reinstall the glove box.

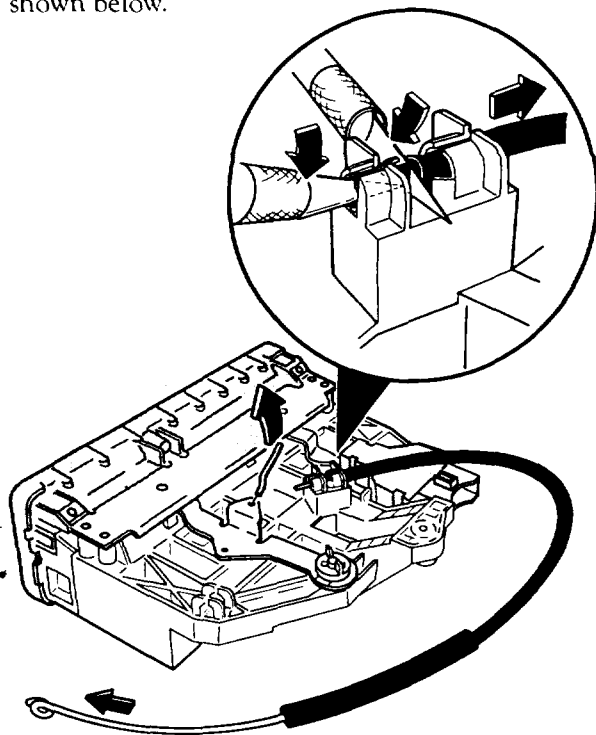
When replacing an air mix cable on a '92-'94 Civic, use the procedure below to cut and remove the cable. If you try to remove the cable housing by just lifting it out of the cable holder, the cable stoppers may break, rendering the heater control panel useless. This procedure is more detailed than the one on page 21-25 of the '92 Civic S/M, and the '93 and '94 Civic S/Ms don't mention cutting the cable at all. (We'll fix that in the '95 S/M.)

1. Cut the inner cable on the lever side of the cable holder, then remove both pieces of the inner cable.
2. Using a sharp knife, cut completely through the end of the cable housing at the two locations shown below.

3. Slide the large section of the cable housing out of the cable holder, being careful not to damage the cable stoppers.
4. Carefully remove the cut pieces of the cable housing with a small flat tip screwdriver.
5. Hook the tip of the new air mix cable to the temperature control lever, then push the cable housing into the cable holder until it locks into place.

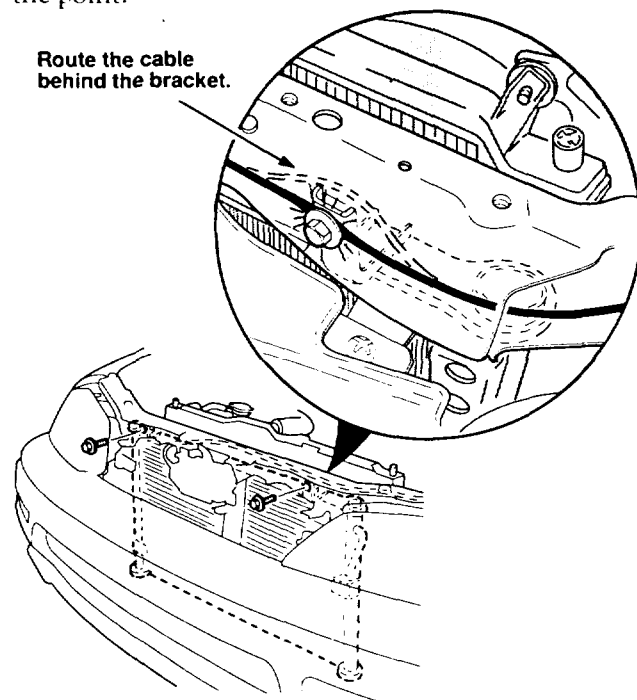
When installing the condenser in a '94 Accord, make sure the hood opener cable is routed behind the upper left condenser bracket before you tighten the mounting bolt. If the cable is between the condenser bracket and the inside of the upper radiator support, it'll get pinched. Step 10 of the '94 Accord A/C installation instructions has a note about this problem, but, judging from the cables that have been replaced under warranty, some people have missed the point.

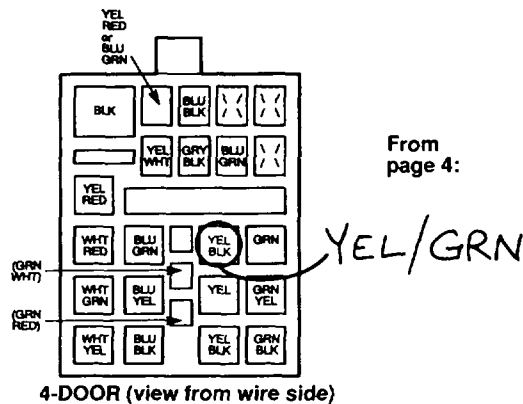
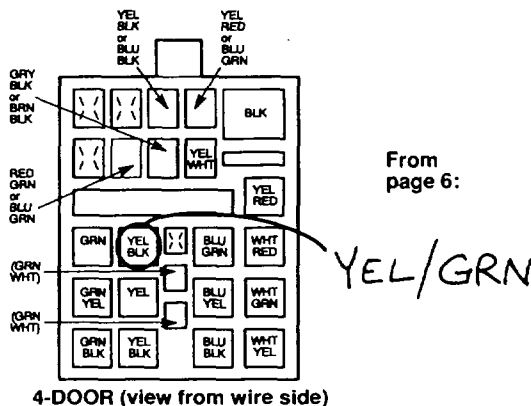
In S/B 93-051, "Electrical Problems in Driver's Door," one terminal is mislabeled in each of the two 4-door connector views. Correct pages 4 and 6 as shown below.
