SERVICE BULLETIN

AUTOMOBILE SERVICE DEPARTMENT

Model	Applicable To	File Under	Bulletin No
ALL	ALL	PDI	87-006
			Issue Date
			OCT 23, '89

Shipping Wax Removal (Supersedes 87-006, dated April 4, 1989)

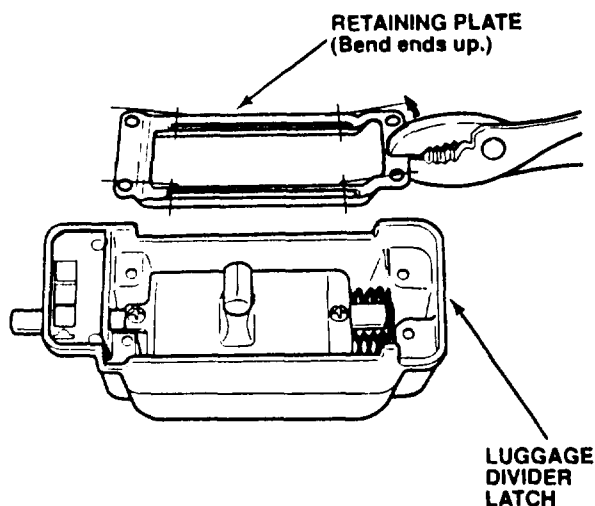
A rattle from the luggage divider area of an '88-90 CRX is usually caused by loose divider latches. To snug 'em up, remove the latches from the divider. Remove the retaining plates from the latches, then bend the ends of each plate up a few degrees. Reinstall the plates and work the latches. The centers of the plates should put just enough pressure on the latches to keep them from rattling, yet still let the latches work freely. Readjust the plates if necessary, then reinstall the latches.

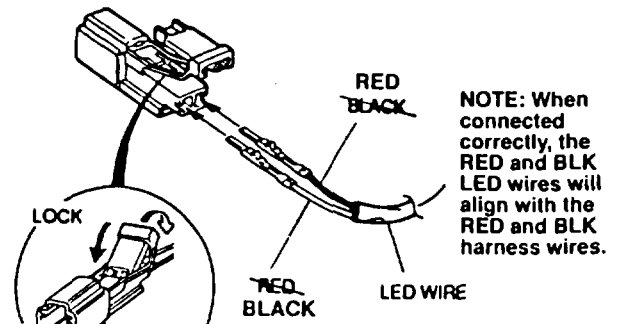
Step 16: The wire positions in the 2-P LED connector are reversed.

If the wires are installed as per the instructions, the LED won't flash when the system is armed. In this case, remove the steering column covers and move the wires to the correct positions. Remove the terminals from the connector with pin removal tool 07JAZ-002050A. If the terminals are damaged, replace them with P/N 07JAZ-001030A. (Both the tool and terminals are in the Terminal Pin Repair Kit, T/N 07JAZ-003000A.) Wrap the connector with a 35 x 65 mm piece of EPT Sealer 3T before you reinstall the steering column covers.

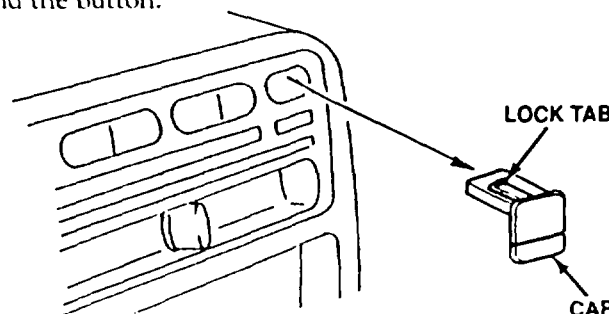
Broken Lock Tab Fouls Civic A/C Button

Before you install an A/C switch button in a '92-93 Civic, take another look at the switch cap you just removed. If the cap's lock tab is broken off, don't install the button until you retrieve the tab from the switch hole. Otherwise, you'll ruin both the panel and the button.

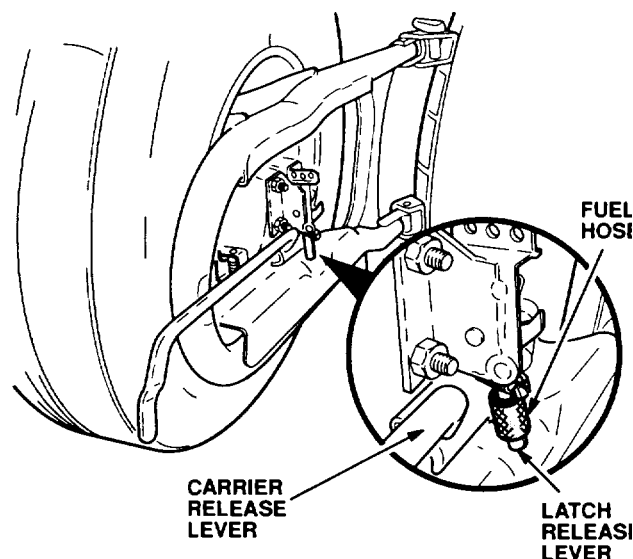
Spare Tire Carrier: When driving over rough surfaces, the spare tire carrier release lever may contact the carrier latch release lever and make a rattling noise. If you hear this complaint, slip a 25 mm length of 7.3 mm I.D. fuel hose over the latch release lever to serve as an insulator.

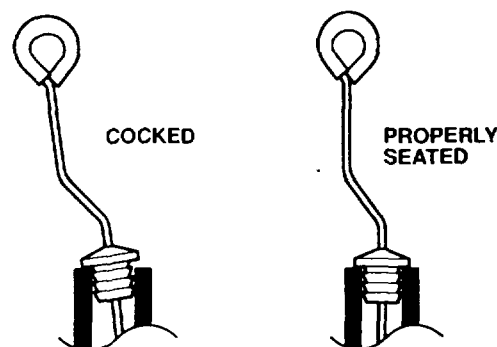
Seat Civic A/T Dipstick Completely

If the A/T dipstick isn't seated squarely in a '92-94 Civic, it can cock enough to contact the reverse shift fork and gear. At the very least, this causes a disconcerting noise; at the worst, it may prevent the trans from engaging reverse. The bend in the handle makes it easy to cock the dipstick, so make sure the rubber plug is seated all the way around.

If you find a dipstick that's had only a minor run-in with reverse gear (it's a little chewed up but all there), replace the dipstick, and flush the trans. If the dipstick is seriously deformed or part of it is missing, the trans will need to be replaced with a remanufactured unit.

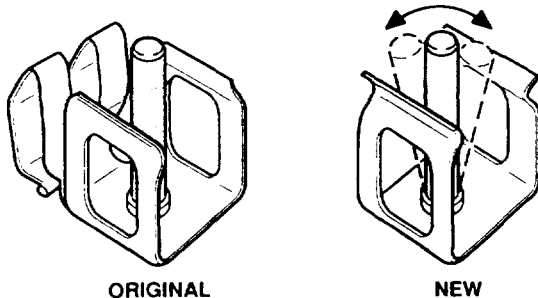
New Shift Linkage Adjuster Pins Wiggle

The new shift linkage adjuster pin used in S/B 94-010, "RECALL: Automatic Transmission Shift Linkage," is supposed to be loose. The pin is not rigidly attached to the clip like on the original part.

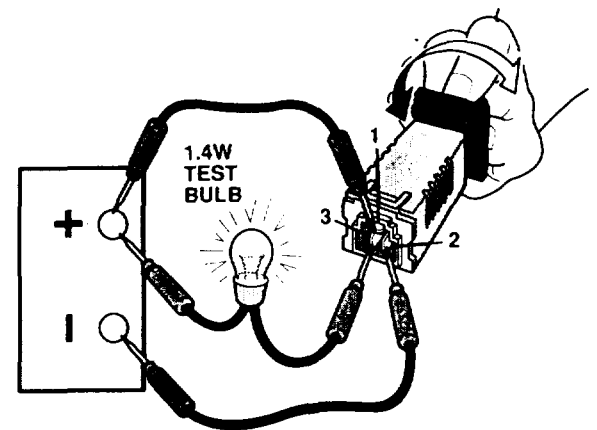
The illumination controller test on page 8-245 of the '94 Passport S/M doesn't work. Because the controller is capacitive instead of resistive, you can't check it with an ohmmeter (the ohmmeter will read open). Instead, use the following procedure to check the controller with a battery and a test light.

1. Remove the illumination controller from the dashboard.
2. Connect battery power to the controller No. 1 terminal, and ground the No. 2 terminal.

3. Connect a 1.4 W test light between the controller No. 3 terminal and battery power.
4. Turn the controller knob clockwise, and check that the light gets brighter. Turn the knob counterclockwise, and check that the light gets dimmer. If not, replace the controller.

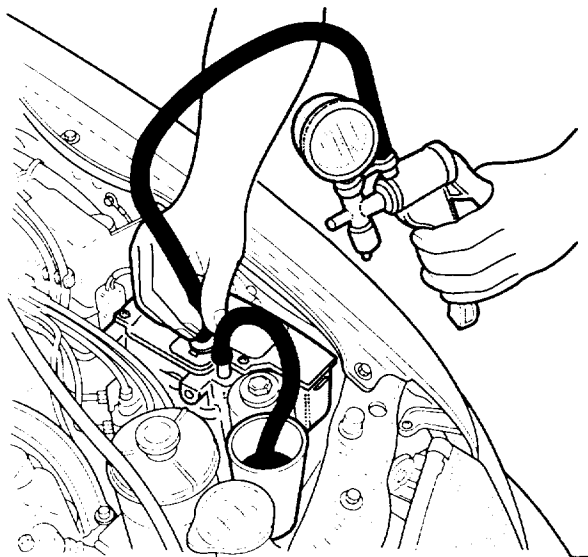
We occasionally hear of a stubborn '94 Accord ABS modulator that still won't build pressure even after the system was bled as described in S/B 93-038, "ABS Light Comes On." Unfortunately, we usually don't hear about it until after the modulator has been needlessly replaced. Before you replace a modulator for this symptom, perform these extra steps:

1. Place one end of a piece of clear tubing onto the bleeder and the other end into a suitable container.
2. Connect a piece of 3/8 inch (10 mm) O.D. hose to the pressure side of a hand-held vacuum pump.
3. Remove the gray rubber cap from the modulator reservoir. Leave the plastic insert in the reservoir fill hole.
4. Start the engine.
5. Hold the other end of the vacuum pump hose against the reservoir fill hole insert, and pressurize the reservoir until you feel resistance in the vacuum pump. (One to three strokes is usually enough.)

6. While the reservoir is pressurized, have an assistant turn off the engine, and open the bleeder (slowly) until the brake fluid stops running in the tube. Close the bleeder.
7. Repeat steps 4 through 6 five times to completely purge the air pocket from the modulator.
8. If you still have a code in the ABS control unit memory, clear it by removing the 15 A ABS fuse for three seconds.

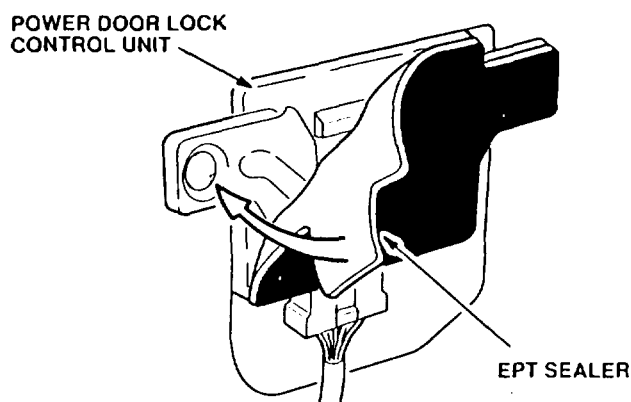
A buzzing noise from the driver's door on a '92 Prelude Si may be caused by the door panel or plastic cover contacting the power door lock control unit. To eliminate the noise, remove the door panel and apply a layer of EPT Sealer 3T to the control unit and control unit bracket surfaces that face the plastic cover/door panel.

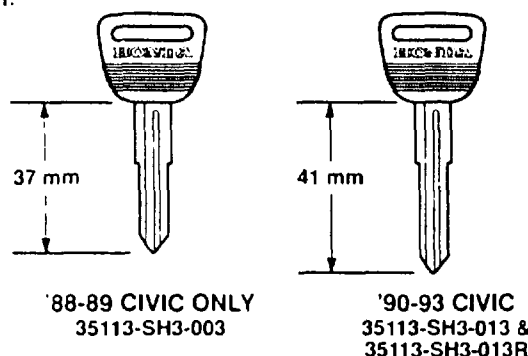
The '88-'89 Civics used a shorter key than the '90 and later Civics. The parts catalogs show the shorter key for '88 models only, but this is incorrect; the longer key is needed only for cars with the shift interlock system.

The shorter '88-'89 key blank now supersedes to the longer key blank, which is fine. But this has caused some people to use the short blank when they needed the long blank. Don't do it! The short key will get stuck if used in a '90-'93 ignition switch. (You can turn it on, but you can't turn it back to the "0" position.) If you have any of the short key blanks in stock, use them only in '88-'89 Civics.

What can you do if you have a short key stuck in a late ignition switch? If it's a genuine Honda plastic-headed key, trim enough plastic off the head until you can push the key in and turn it to "0."

If it's an all-metal key or an aftermarket key, first remove the steering column covers. Turn the switch to "I." Push in the pin on the lock body, and pull the lock cylinder out about 1/2 inch. Now you can turn the key to "0" and remove it. Insert a key cut on a long blank, turn the switch back to "I," and push the cylinder back into the body. Reinstall the column covers.

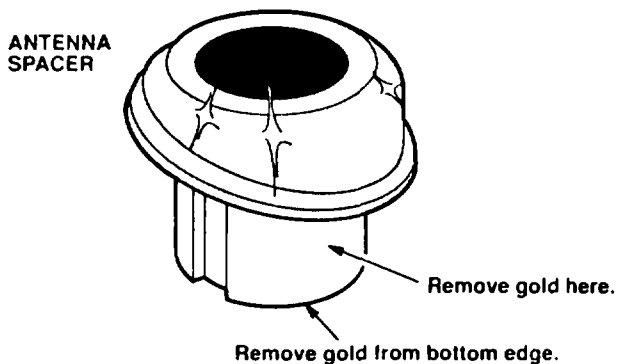
If an Accord or Prelude comes in with a radio reception problem, check the car for a gold emblem kit. What do gold emblems have to do with radio reception? Nothing, but that gold antenna spacer might be the culprit.

Remove the gold antenna nut and the antenna spacer, and inspect the part of the spacer that goes inside the fender. If that area is gold plated (it's not supposed to be), the spacer may be acting as a conductor to ground instead of as an insulator.

Using a utility knife or file, remove the gold plating from the lower part of the spacer and its bottom edge.

Loosely reinstall the antenna spacer and antenna nut. Loosen the antenna motor mounting nuts, then retorque the antenna nut to 20 lb-in. (Loosening the motor allows the antenna collar to make a good ground when you torque the antenna nut.) Retighten the motor mounting nuts.

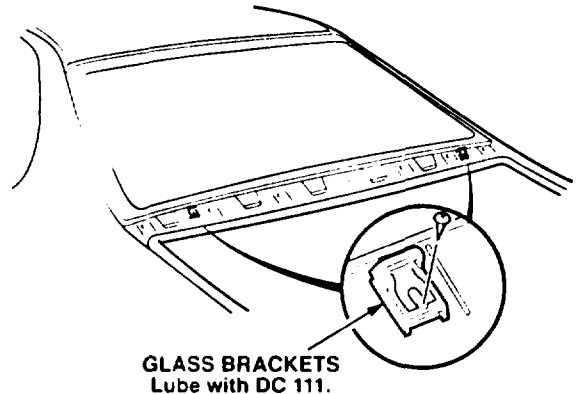
Rear window glass brackets: Contact between the rear window and the glass brackets may cause a clicking noise when driving over irregular surfaces. (These brackets are used to align the window up and down during installation.) If you suspect this is the cause, remove the lower molding, and lubricate the glass brackets with DC 111.

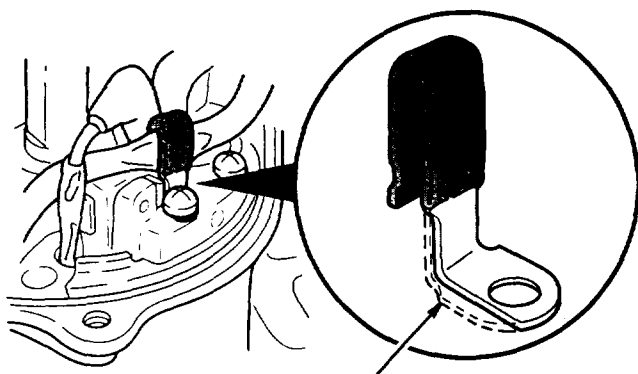
The updated igniters for the '91 Accords are shaped a little differently than the original igniters. However, this slight difference creates some interference with the wire retainer that goes under one of the igniter mounting screws. It is possible to force the wire retainer and mounting screw into position, but it moves the wires out of position, and you run the risk of cross-threading the screw. So, before you install the wire retainer, reshape it with your bench grinder as shown.

Remove with grinder.

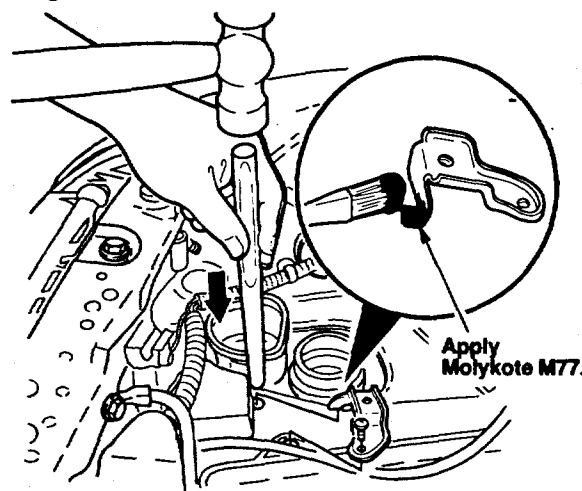
While this is still true, this problem has eluded many people because the noise doesn't always sound like a "buzz," and it doesn't always occur when accelerating. This symptom has also been described as a clicking, creaking, rattling, squeaking or ticking noise, and sometimes it occurs only during deceleration, braking, or when there are two people in the car. In other words, don't get too hung up on the symptom; if there's a noise coming from the right-front corner of the car, try the air cleaner bracket first!

We've also come up with a better "fix" for this problem. First, remove the air cleaner housing and the front bracket. One end of the bracket is held by bolt, while the other end is held by a tang. Using a blunt drift, slightly dimple the hole (in the body) that the tang fits into. (This will put more tension on the bracket.) Then, dab some Molykote M77 on the tang, and reinstall the bracket and the air cleaner housing.

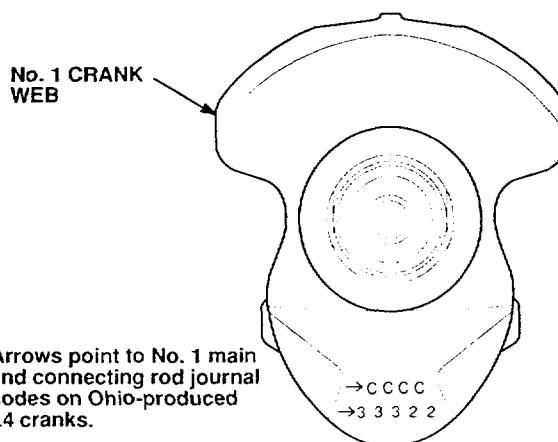
The system for marking the crankshaft wasn't so logical, so the factory added an arrow that points to the No. 1 main bearing journal mark. (Once you know where No. 1 is you can't go wrong.) There's also a similar arrow that points to the No. 1 (pulley-end) connecting rod journal mark.

Arrows point to No. 1 main and connecting rod journal codes on Ohio-produced L4 cranks.

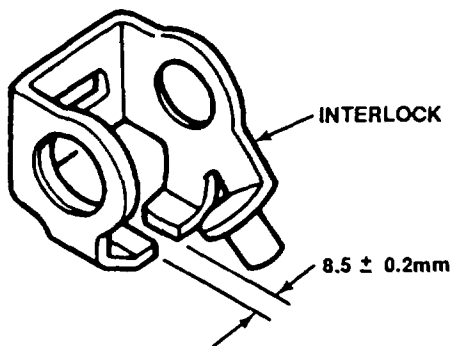
If a '90 - 92 Accord comes in with a bound-up M/T, the trans may be stuck in two gears. If this is the case, it's a safe bet that someone has been forcefully shifting the trans and bent the interlock. Luckily, the interlock can be inspected and replaced without removing the trans.

Remove the interlock as described in the M/T section of the S/M, then measure the width of the interlock guide channel. The channel width should be 8.5 ± 0.2 mm. If the channel has been spread, replace the interlock.

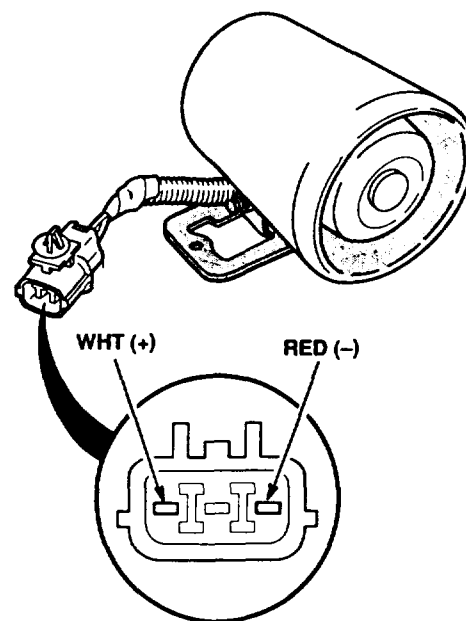
View from terminal side.

If you need to test the security system siren on a '94 Accord, Civic, or Prelude, be careful how you connect power and ground. Contrary to common practice, you apply power to the WHT siren wire and ground the RED wire. If you do it the other way, you'll ruin the siren.

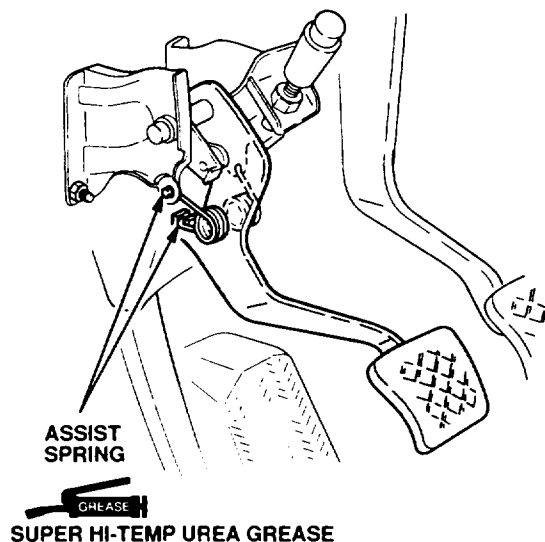
A "spring noise" when you slowly depress and release the clutch pedal on a '94 Accord may be caused by a dry clutch pedal assist spring. Lubricate the assist spring pivot points with Super Hi-Temp Urea Grease, P/N 08798-9002, where shown.

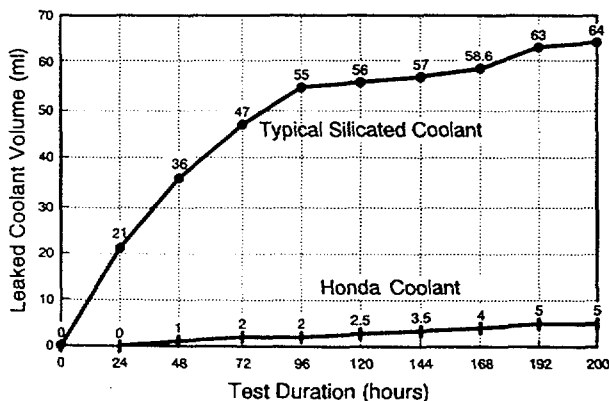
Coolant Leakage From Water Pump Seal

- Silicates bond to the surface of the water pump seal and act as an abrasive, causing considerable seal erosion and coolant leakage. In actual tests, the silicated coolant caused early leakage. This leakage increased dramatically until a substantial portion of the coolant had been lost. In contrast, the Honda coolant had almost no leakage through the duration of the test.

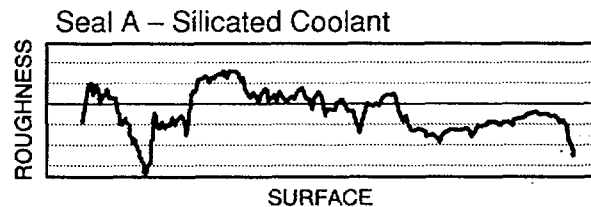
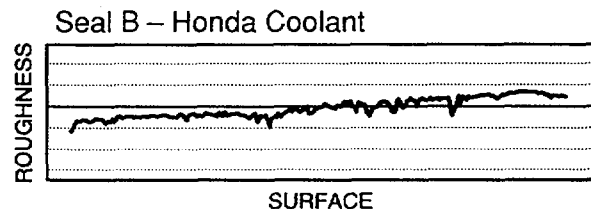
Surface Roughness of Aluminum Seal Ring

- No silicate abrasion of water pump seals. For example, these graphs show the surface roughness of two aluminum water pump seal rings. Seal A, exposed to silicated coolant, shows considerable damage. Seal B, exposed to Honda coolant, displays only minute wear.

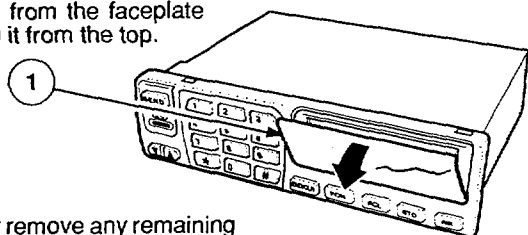
If a customer damages the display lens on an in-dash cellular telephone, you can replace it. The replacement lens is P/N 08E01-SV4-900RE, H/C 4724647, and it comes with alcohol pads to help remove any remaining adhesive from the phone's faceplate.

Remove the damaged display lens from the faceplate by prying it from the top.

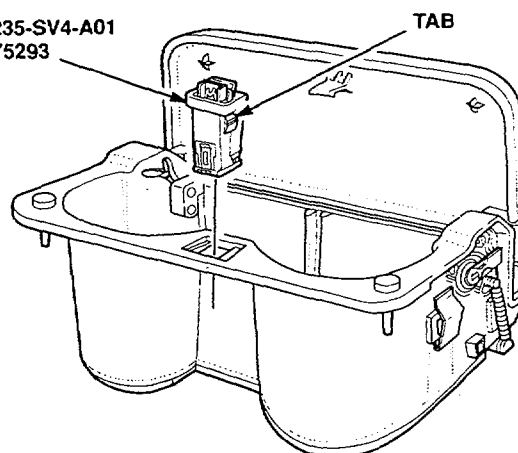
LATCH
P/N 77235-SV4-A01
H/C 4275293

If you encounter a cup holder lid that won't latch on a '94-'95 Accord, don't rush to replace the cup holder assembly; first, check for an improperly installed or broken latch. Make sure the latch is fully seated in the cup holder. If the latch is broken, release the two tabs on the latch, and remove it from the cup holder. The new latch (P/N 77235-SV4-A01, H/C 4275293) simply snaps into place. Your parts department should be happy to stock a couple of small, inexpensive latches as opposed to several cup holders in all the available colors. Paying customers will also be happy; the latch currently retails for about \$8.00, while the whole cup holder sells for about \$50.00.

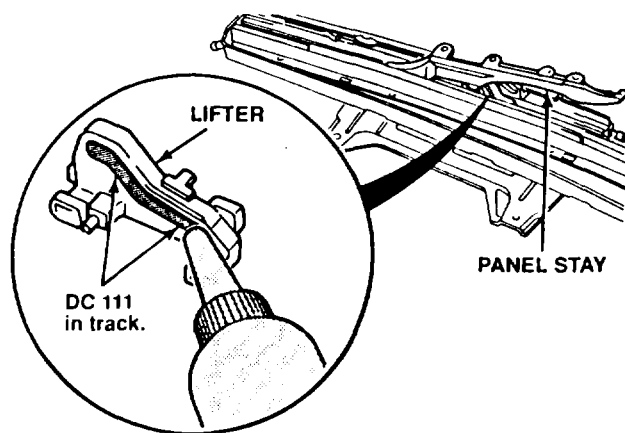
There are two bulletins that address sunroof squeaks on '92 Preludes: S/B 92-014, "Squeaks From Open Sunroof" and S/B 92-028, "Squeaking From Closed Sunroof." When going after either problem, lubricate the inside "track" or ramp on the sunroof lifter with DC 111. A lack of lubrication in this area is another potential cause for a squeak.

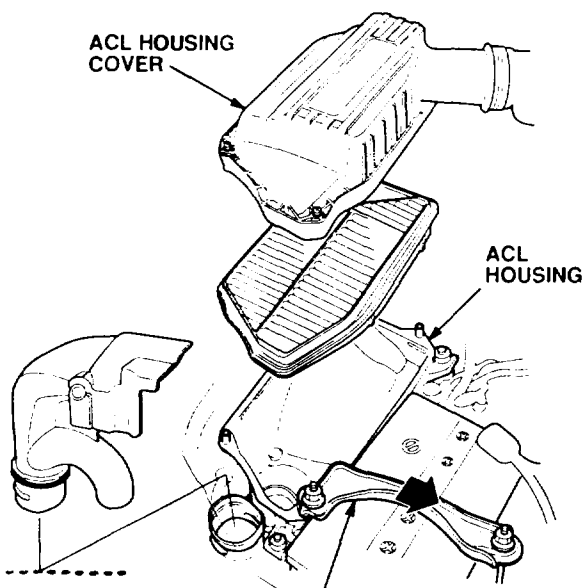
When removing or reinstalling the air cleaner housing cover from a '94 Accord, loosen the battery hold-down stay and push it away from the air cleaner. At the factory, the air cleaner goes in before the battery, and it's possible to damage the cover or element if you try to pry them out without first loosening the battery stay.

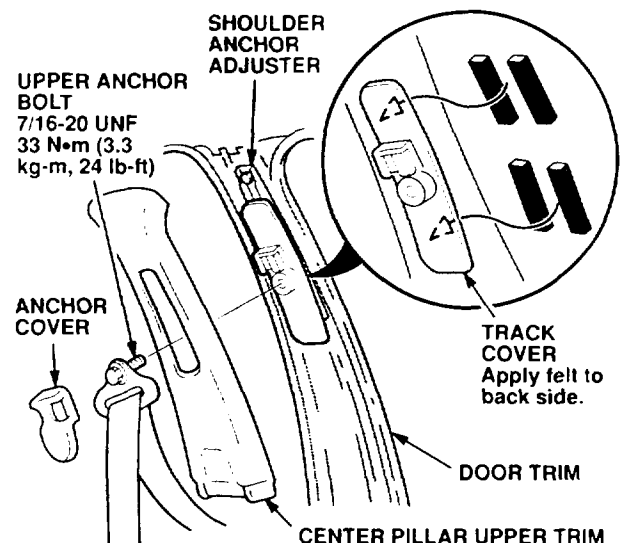
The front shoulder belt anchor adjuster on some '94 Accord Sedans may make a buzzing noise when you drive the car over irregular surfaces. You can usually duplicate the noise by lightly tapping on the plastic anchor adjuster track cover (under the upper center pillar upper trim). To eliminate the noise, insert some felt between the anchor track and the track cover, as described below.

1. Remove the front and rear door opening trim from the center pillar area.
2. Remove the anchor cover and the upper anchor bolt.
3. Pull back the top of the lower center pillar trim, and remove the upper center pillar trim.
4. Cut some 6-mm-wide strips of felt (P/N 06993-SA5-000), and apply them to the back of the track cover, where they contact the track.

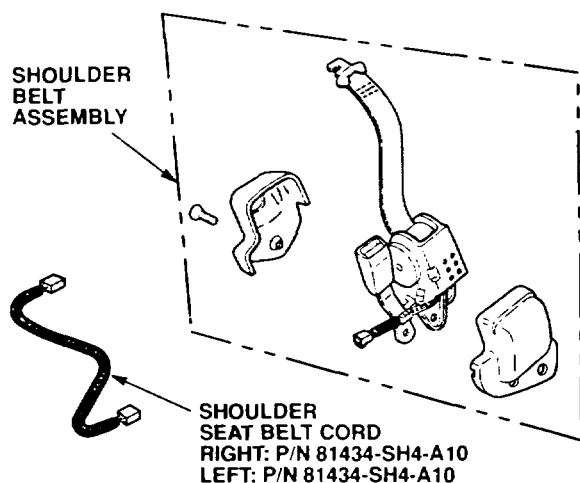
The original replacement front shoulder belt assemblies for Ohio-produced '90-91 Civic Sedans came with a 14" wire harness. These assemblies will be discontinued as current stock is depleted.

The new shoulder belt assemblies will have a 2" wire harness, so you'll need to order a separate connecting cord (sub-harness) when installing one in an Ohio-produced car. Parts Information Bulletin A93-0057, filed under New Parts, has all the old and new part number information.
